# Loomis Creek Eco-hydrology Phase 1 Study: 2024-2025

May 27, 2025

Fintegrate file #: 2025-CPAWS-01

**Prepared for:**

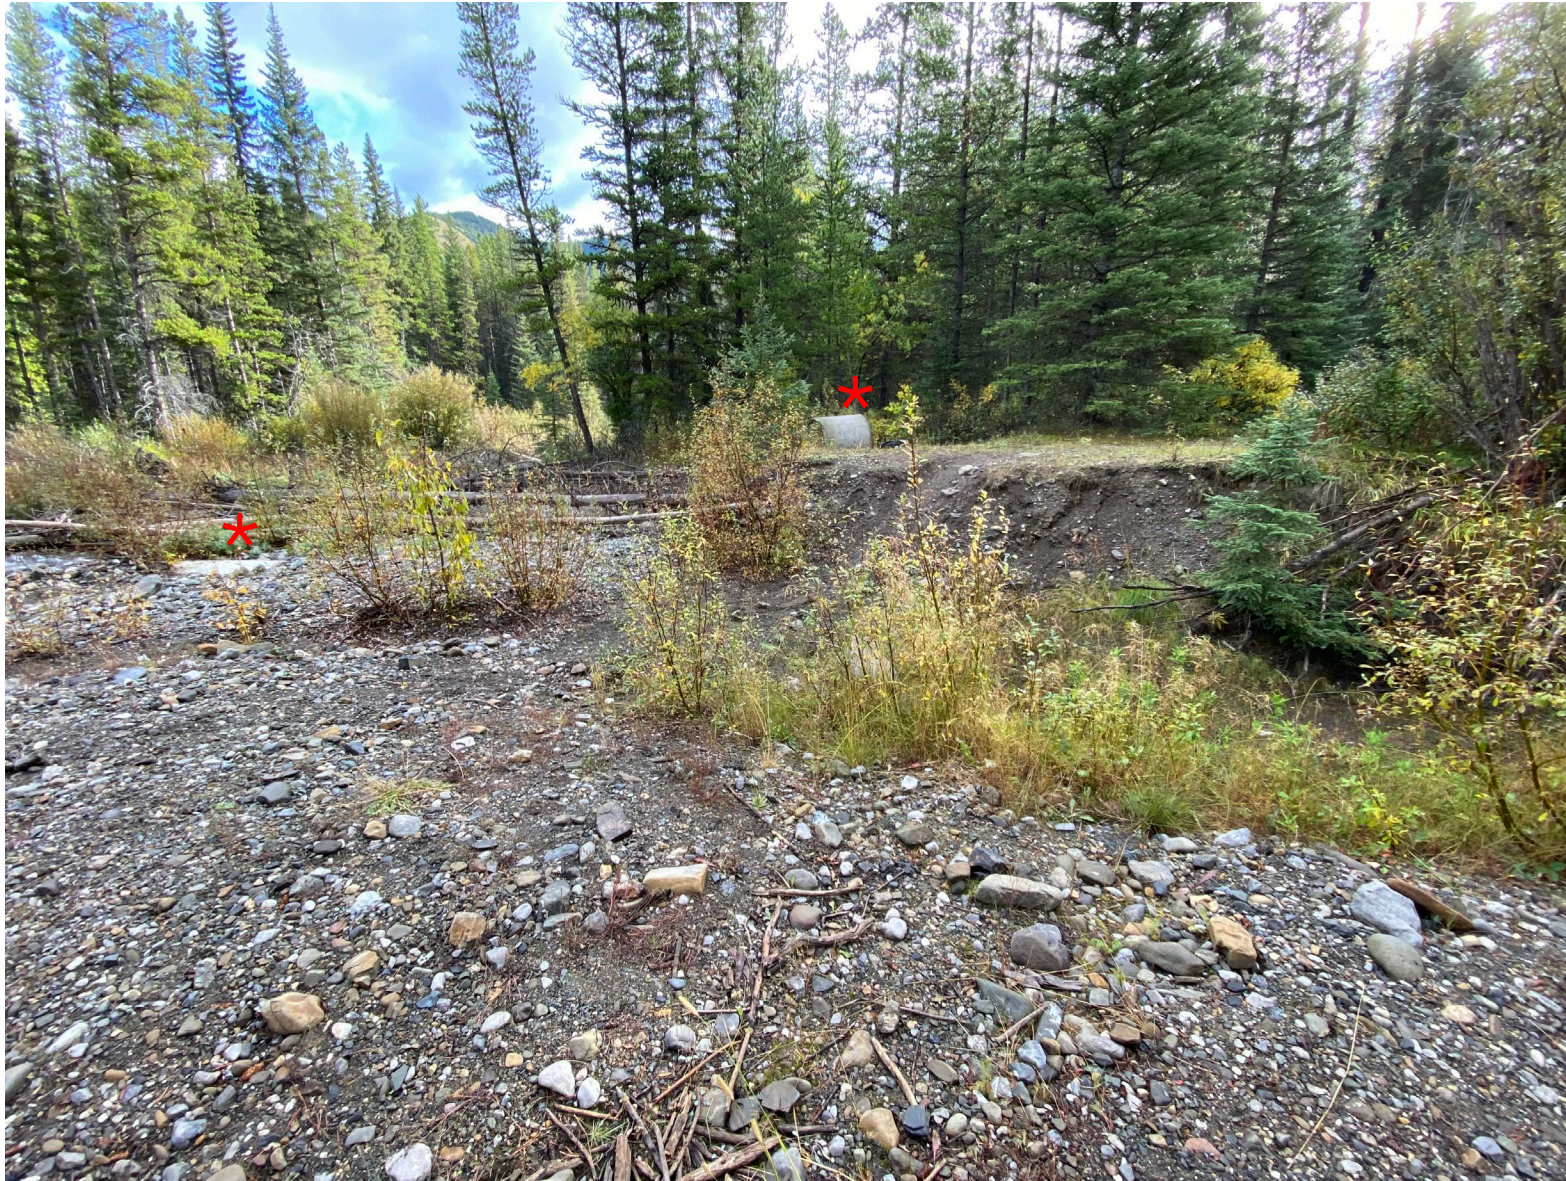
**Photo 1. Loomis Creek Blowout Crossing showing channel avulsion and pieces of a concrete culvert (\*).**

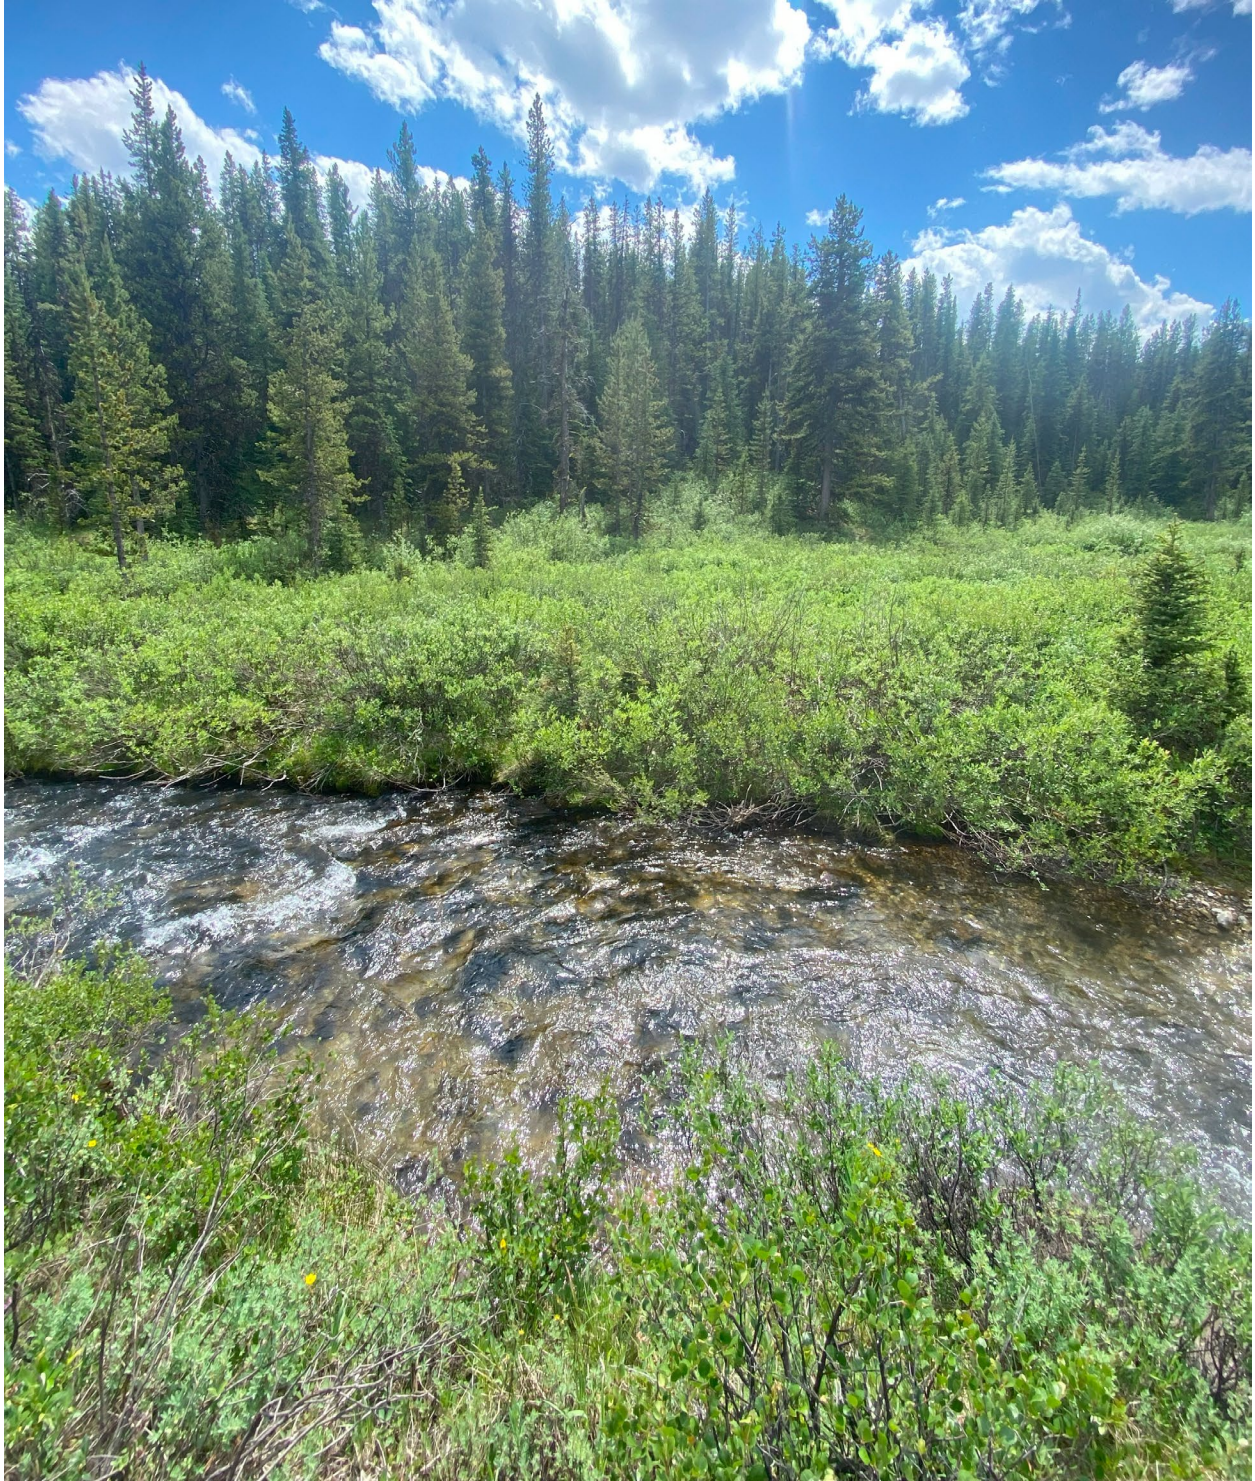
**Photo 2. Planned Loomis Creek crossing site near the downstream limit of the beaver meadows and immediately upstream of where bull trout spawn.**

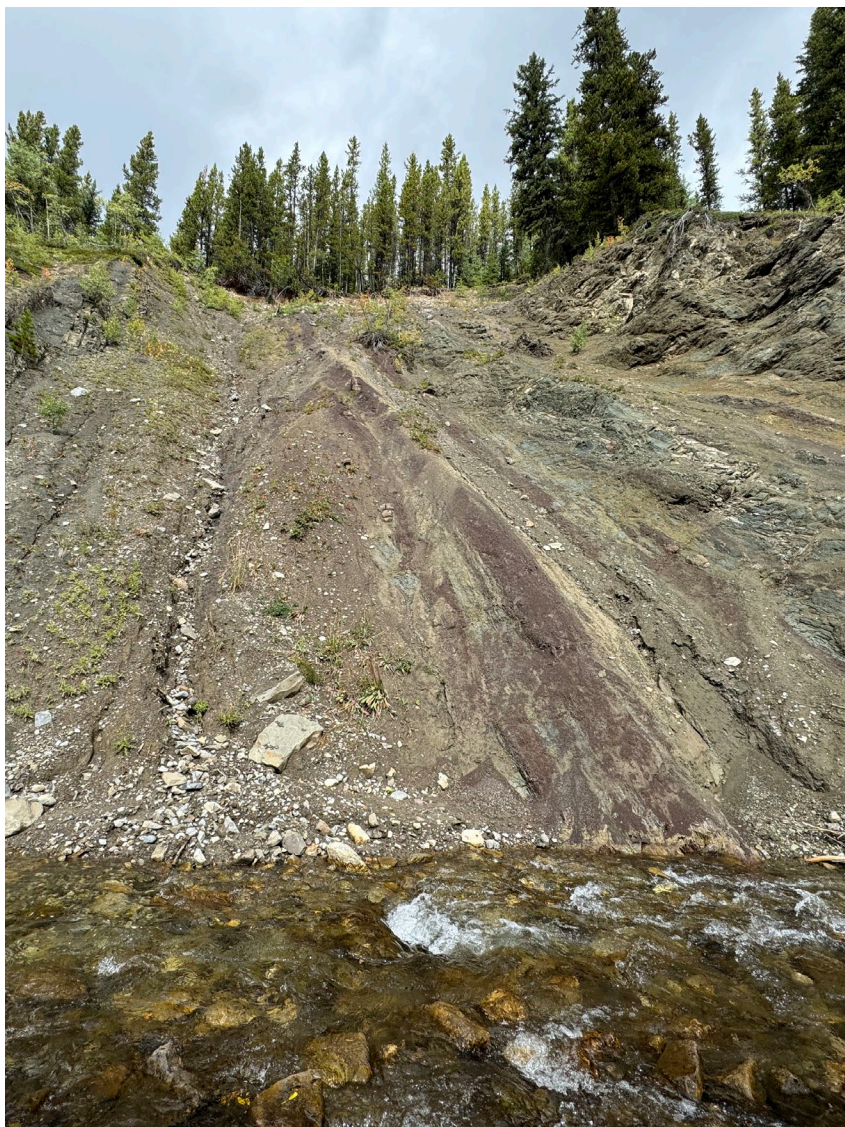
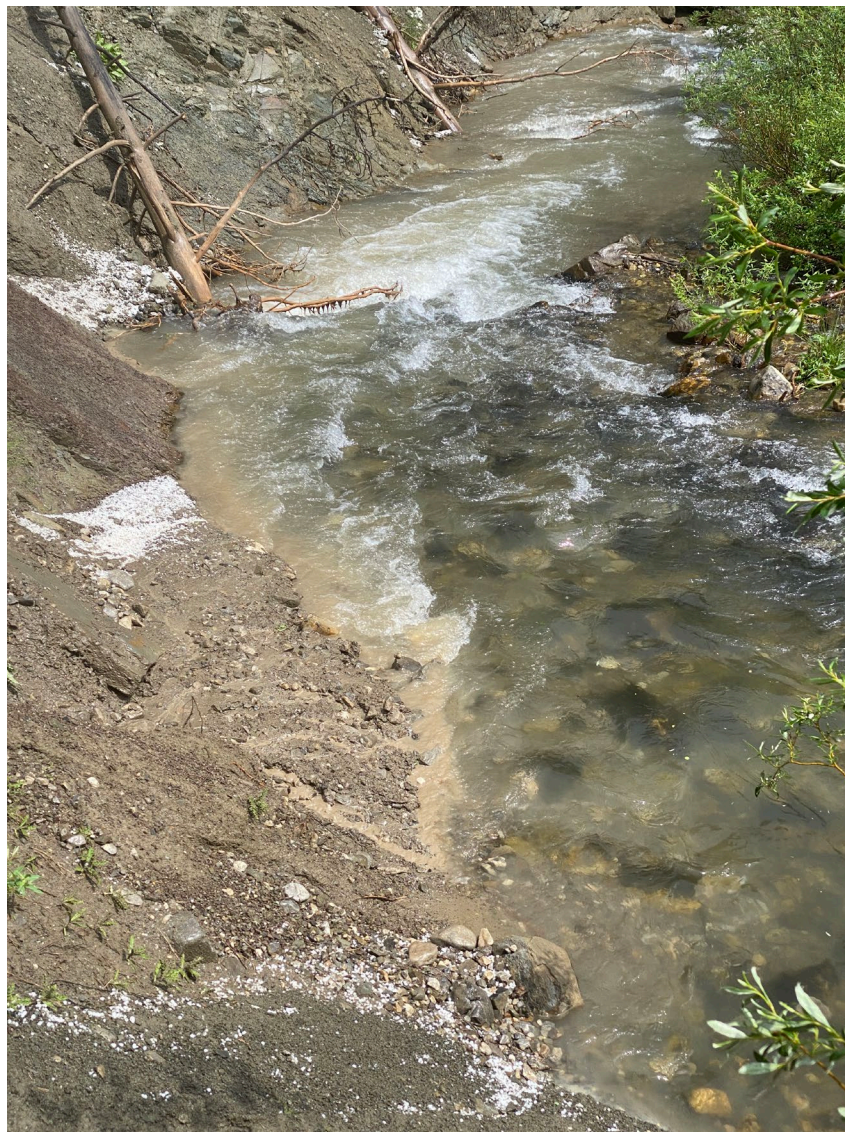
One large point source of ongoing sediment inputs to Loomis Creek was observed approximately 350 m downstream of Bishop Creek where a steep valley escarpment on the North bank is actively eroding and releasing substantial amounts of fine gravel, sand, and silt during rainfall events (**Photo 7**). It is not known whether the bank escarpment was destabilized by flooding triggered by hydrologic changes following historical fire or logging, but it is evident on 1949 areal imagery and is not associated with historical logging road construction. Fine sediment from the site resulted in a pulse of TSS that reached the Highwood River on July 17, 2024, while fine gravel from the eroding escarpment is building up in Loomis Creek immediately downstream of the site (**Photo 8**).

**Photo 7. Actively eroding escarpment on Loomis Creek near Bishop Creek during July 17, 2024, rain event.**

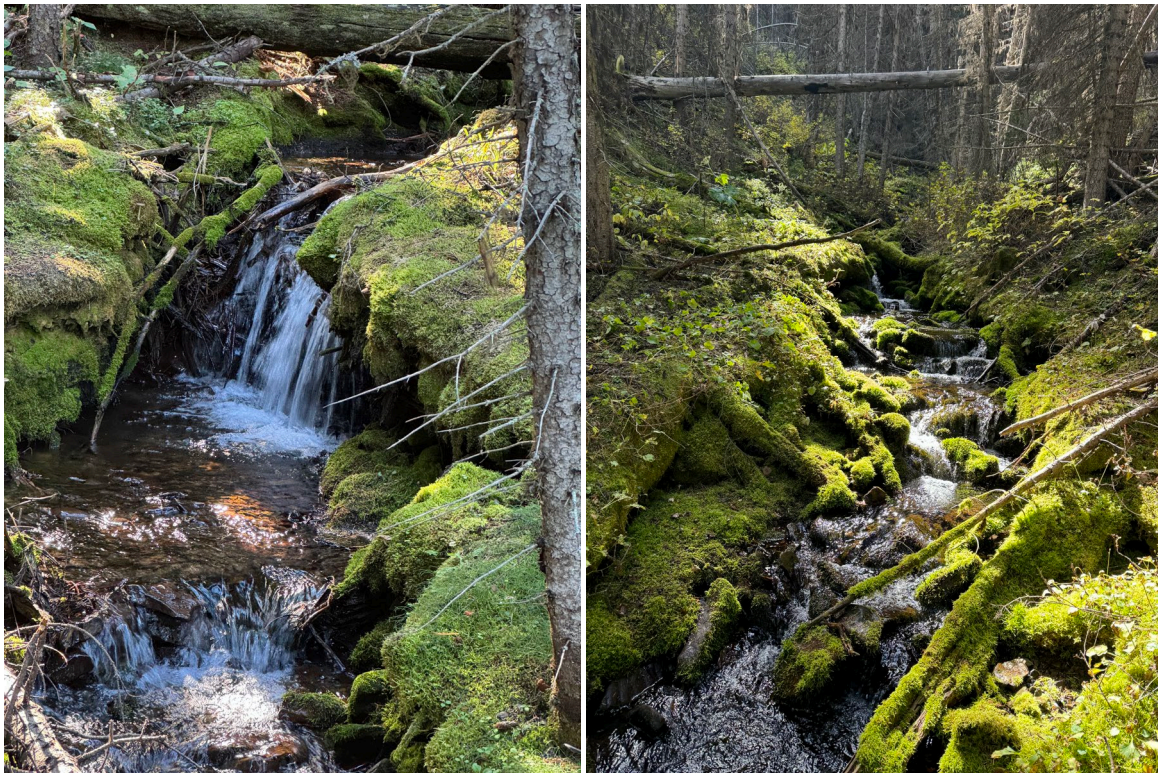
**Photo 12. LSBS6 forced step pool incised channel within historical wildfire area.**

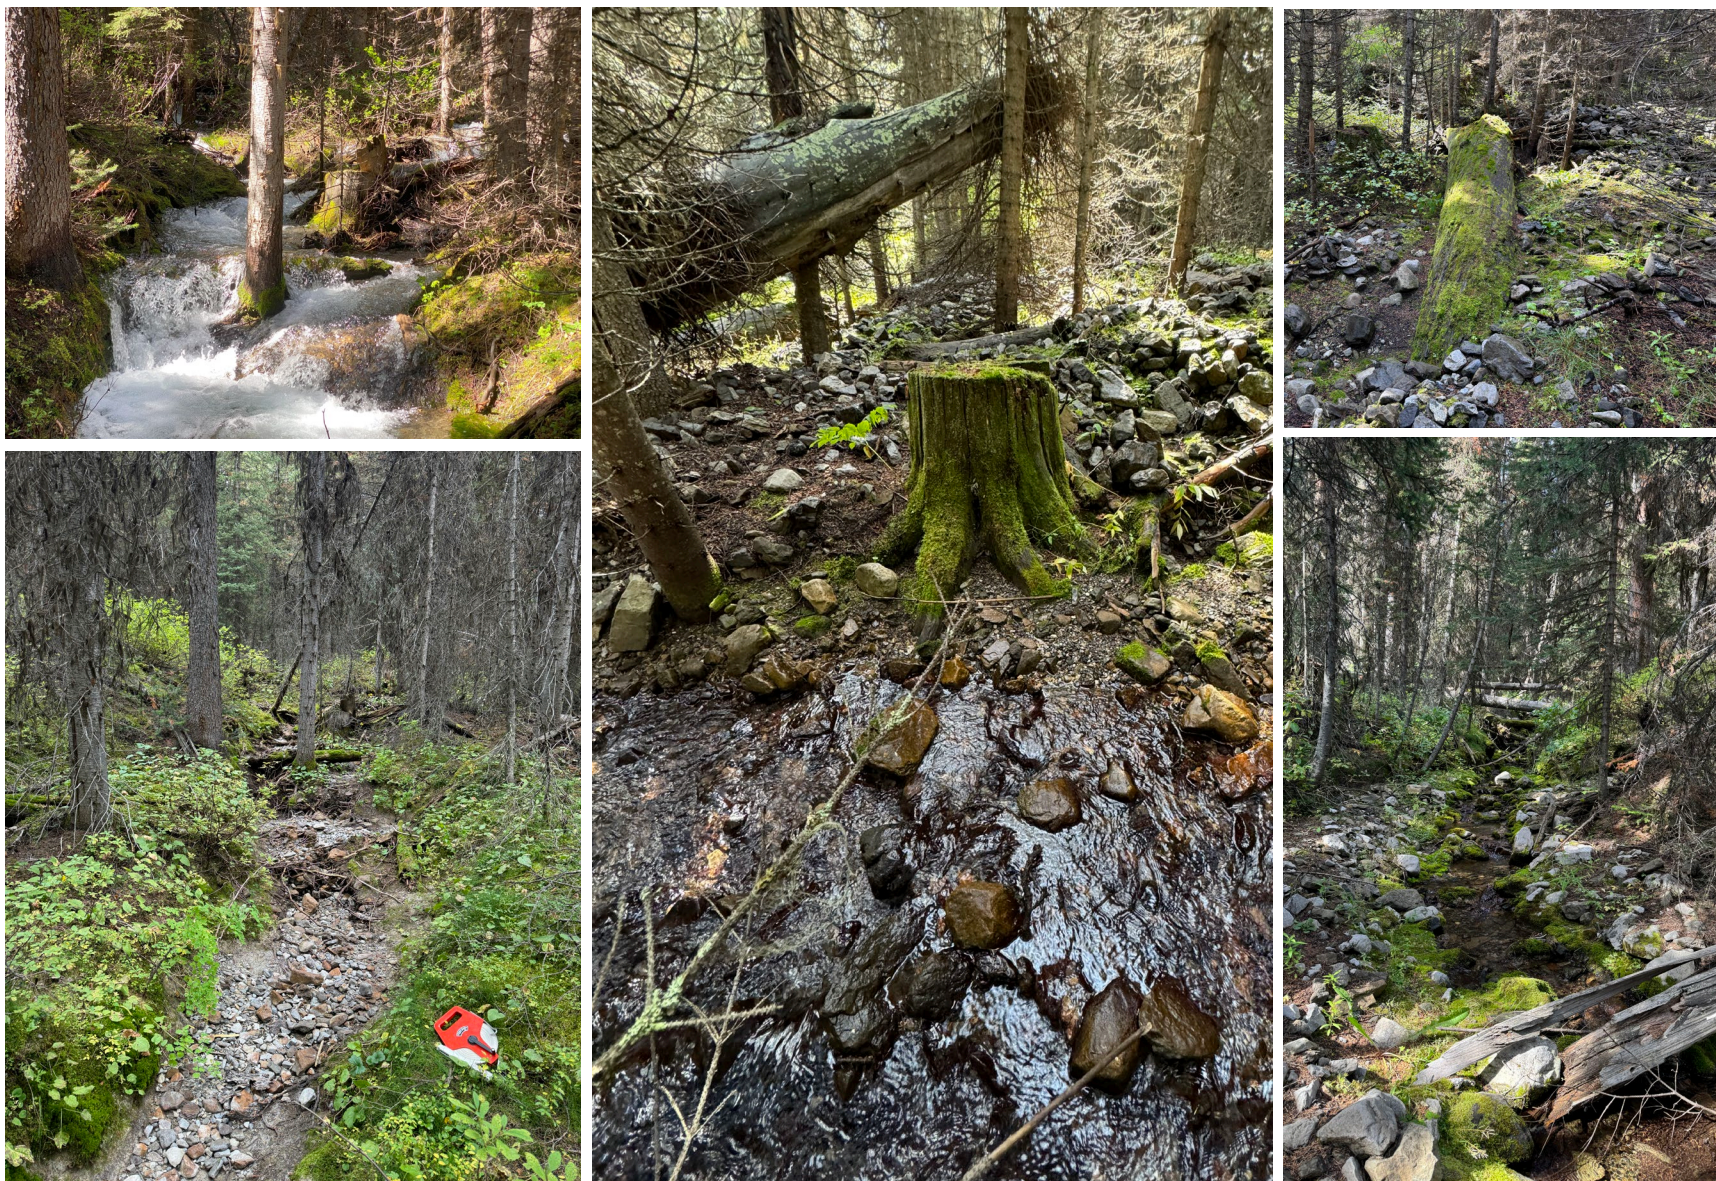
**Photo 13. LSBN9 new channel (July vs. September, left), old channel (bottom right), avulsion (middle and top right).**

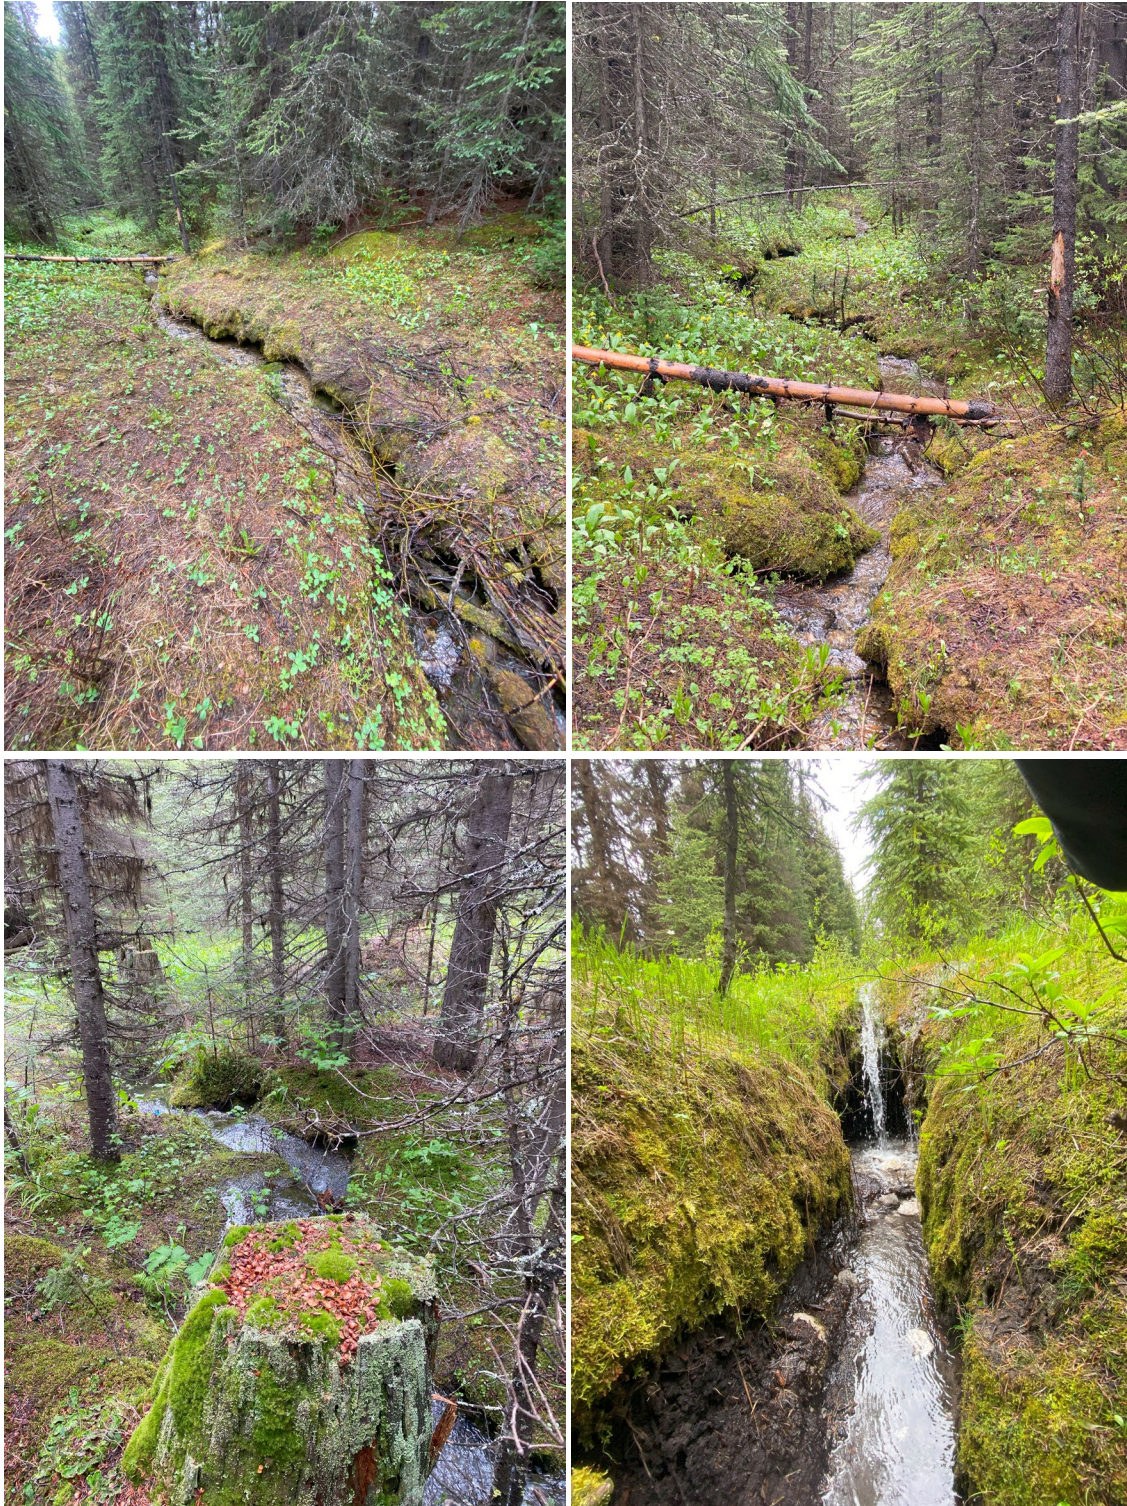
LSBN8 and LSBN5 sub-basins are smaller than LSBN9 and do not have areas above tree line. The site downstream of some of the historical logging on LSBN8 shows substantial bedload movement in some locations ([Online Map Site ID: CM09](#)). The site downstream of most of the historical logging on LSBN5 shows channel incisement (**Photo 14**).

**Photo 14. Channel incisement on LSBN4 (top) and LSBN5 (bottom) within and downstream of areas historically logged.**

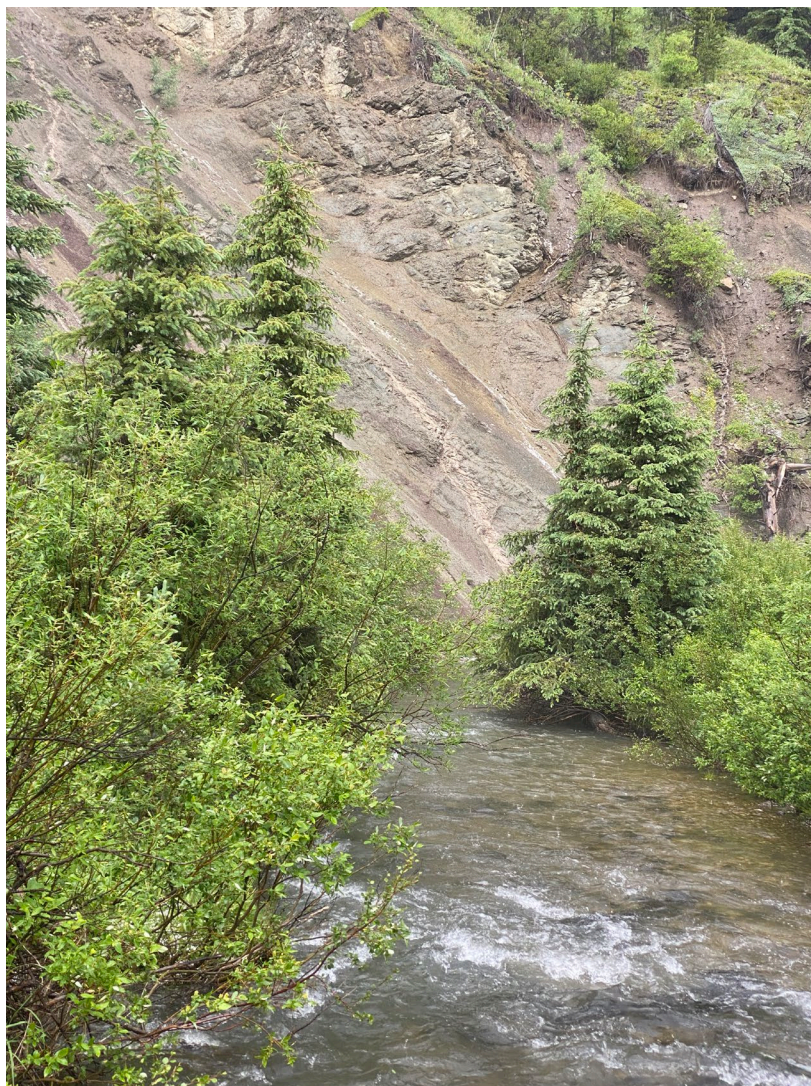
**Photo 15. Low turbidity in Loomis Creek upstream of escarpment during erosive event.**

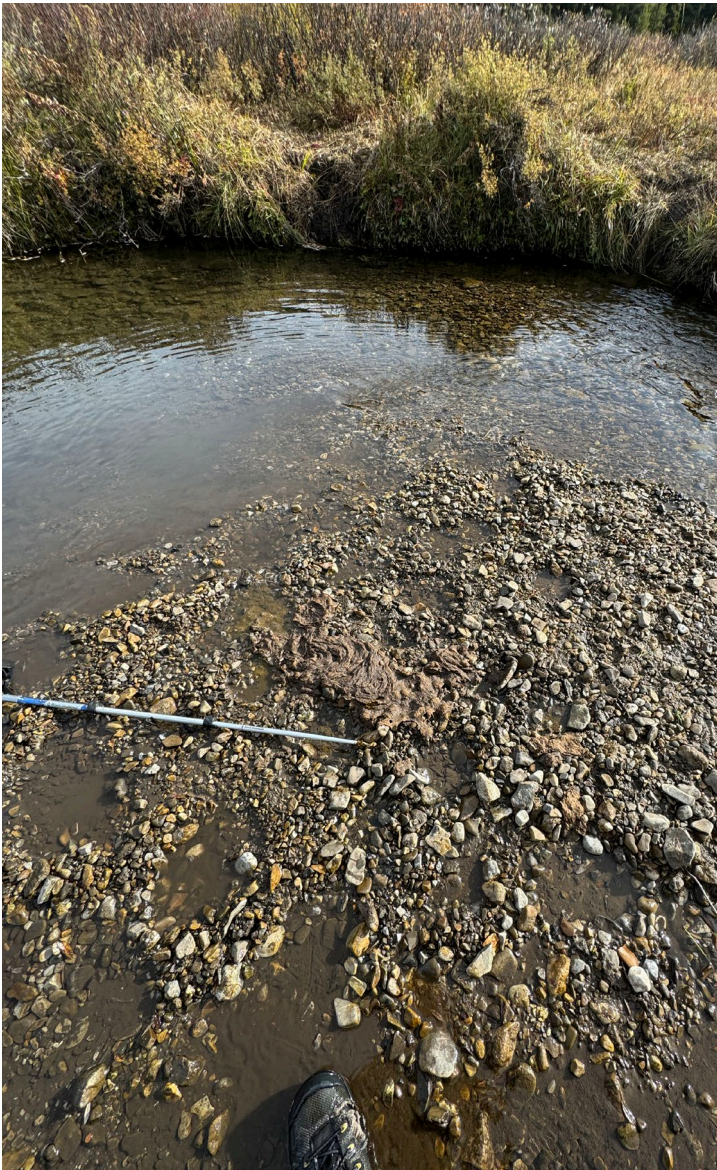
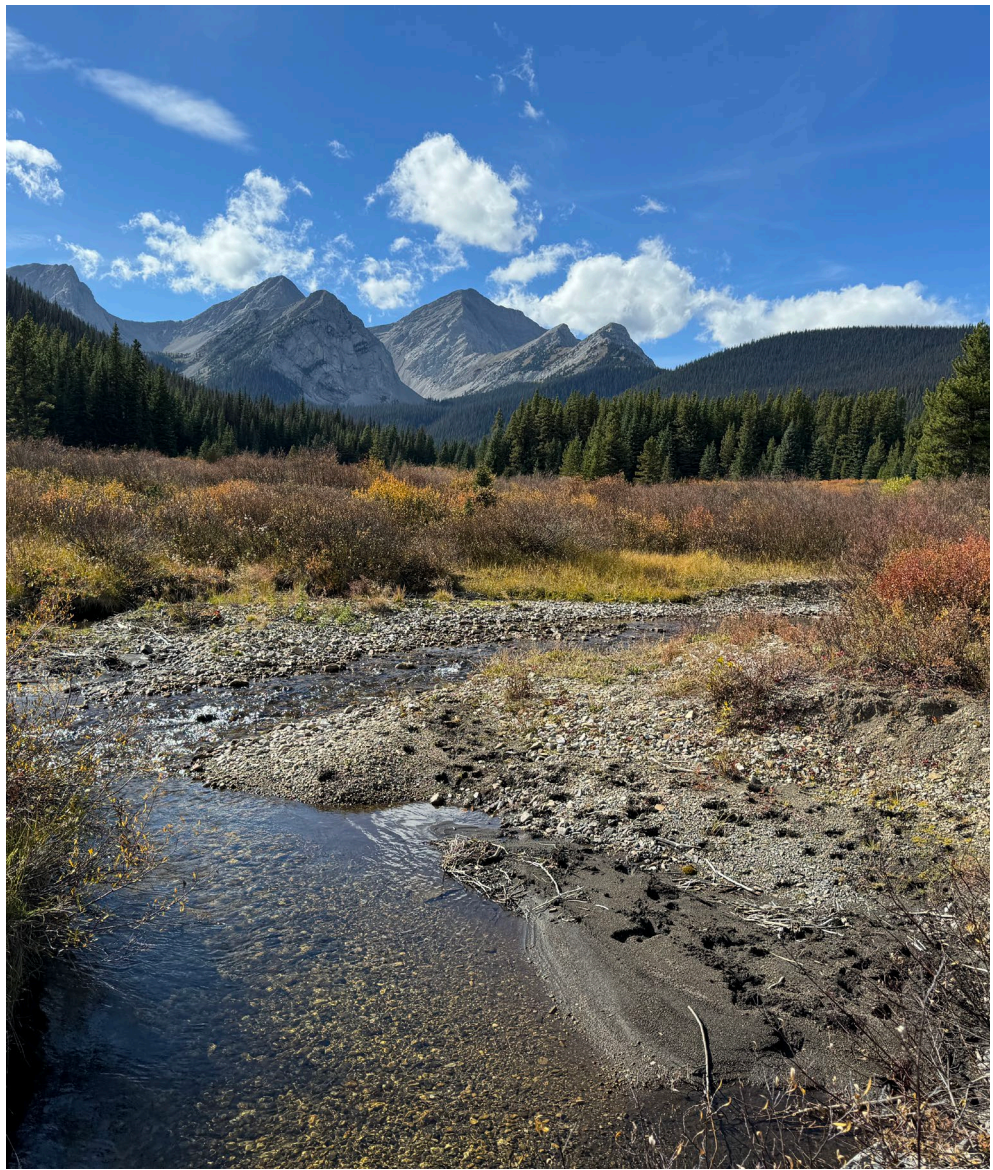
**Photo 19. Cattle damage to bull trout spawning habitat and riparian habitat on Loomis Creek.**

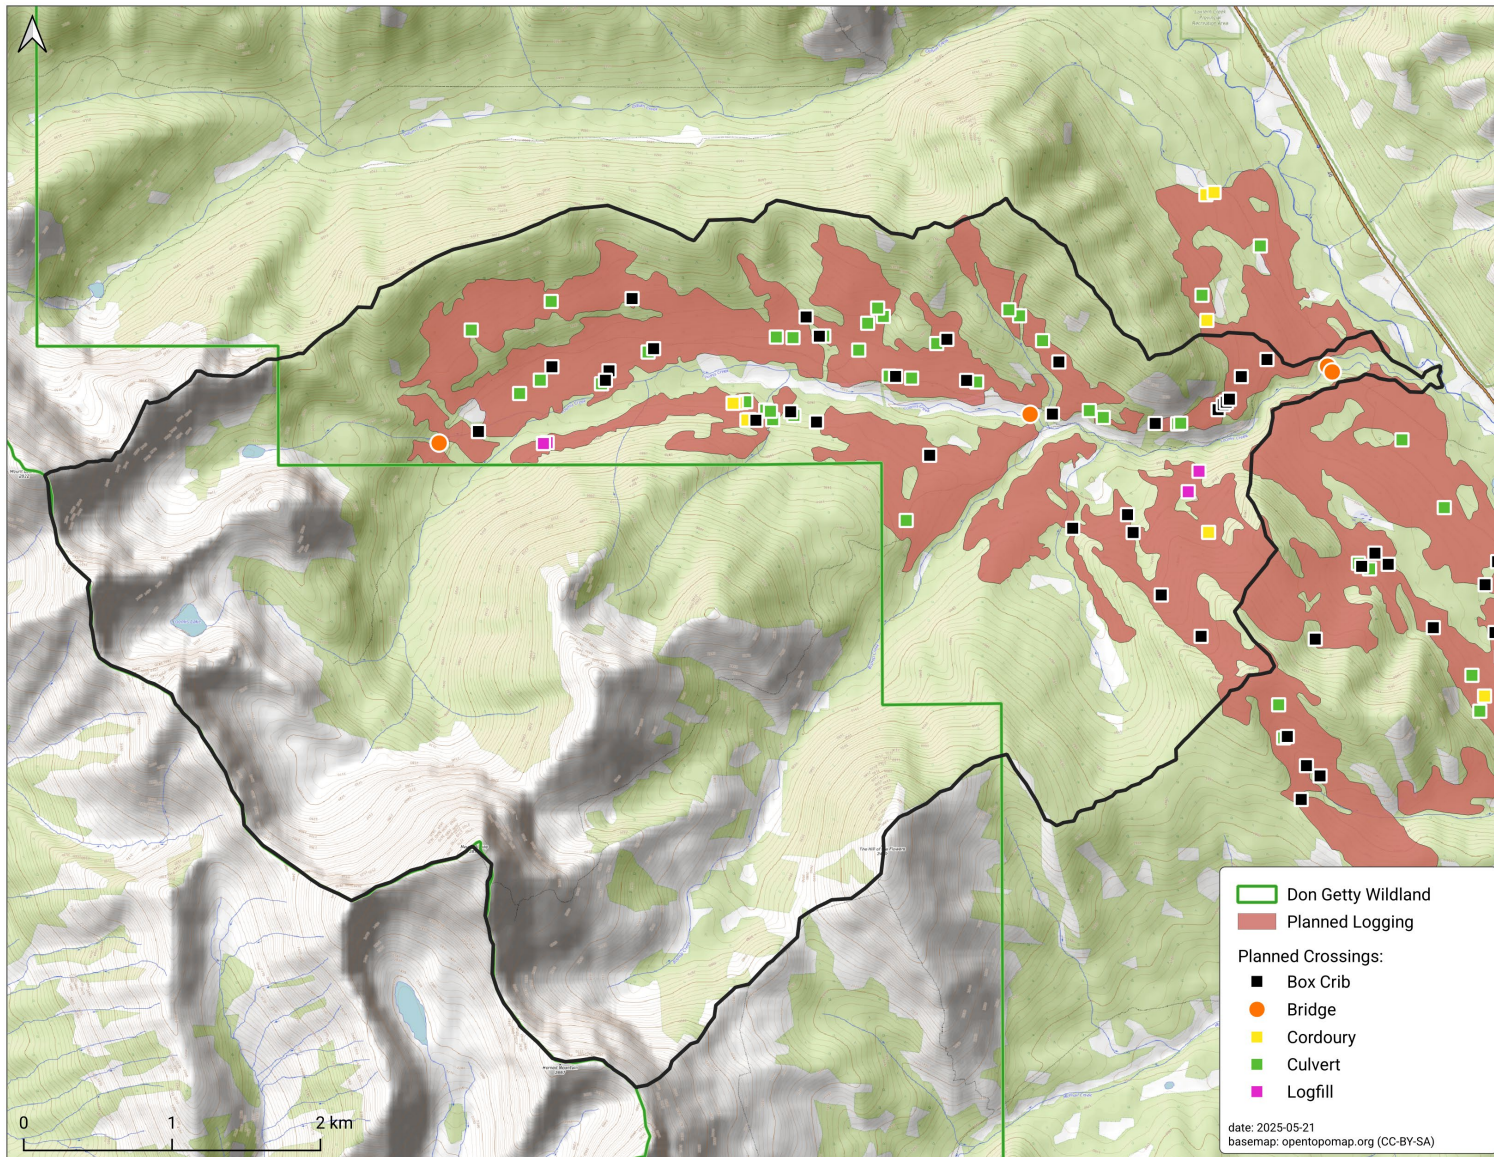
**Figure 31. Planned crossings where roads are on a water feature that has not been buffered out of the cut block.**

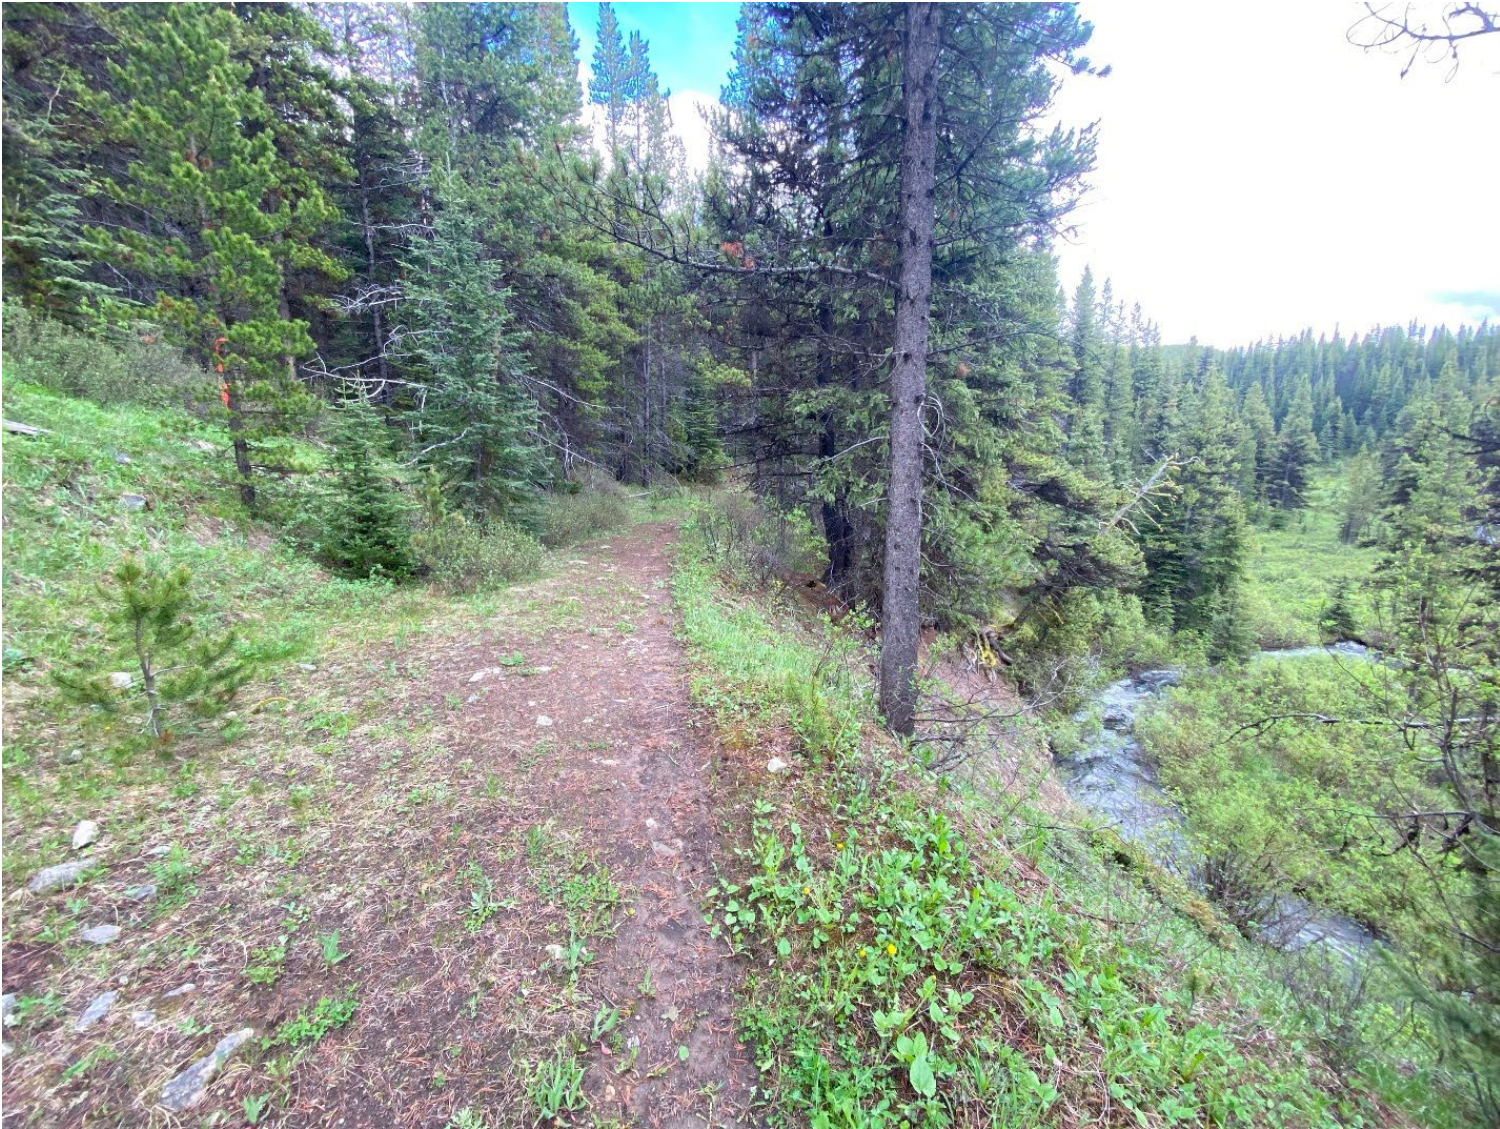
**Photo 20. Location where a cut block boundary and planned road overlap the historical road and are within 10 m upslope from Loomis Creek where two bull trout redds were observed.**

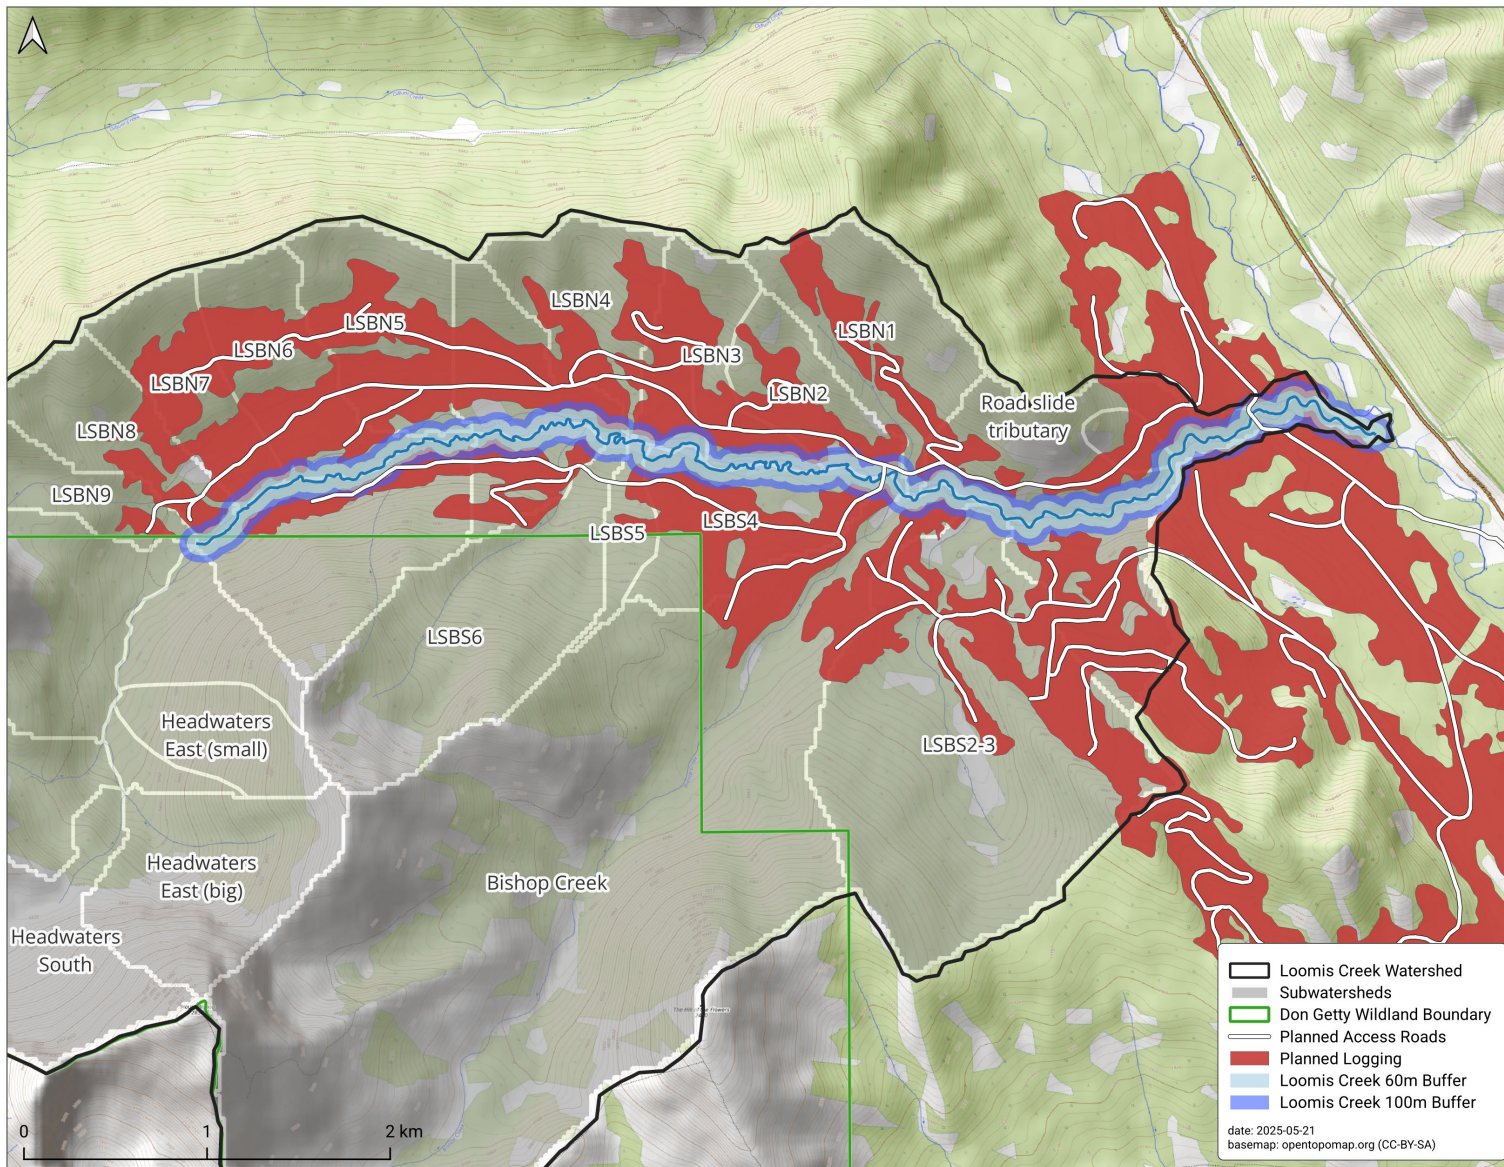
**Figure 32. Parts of planned road and cut blocks within respective 100 m and 60 m buffers on large permanent streams.**

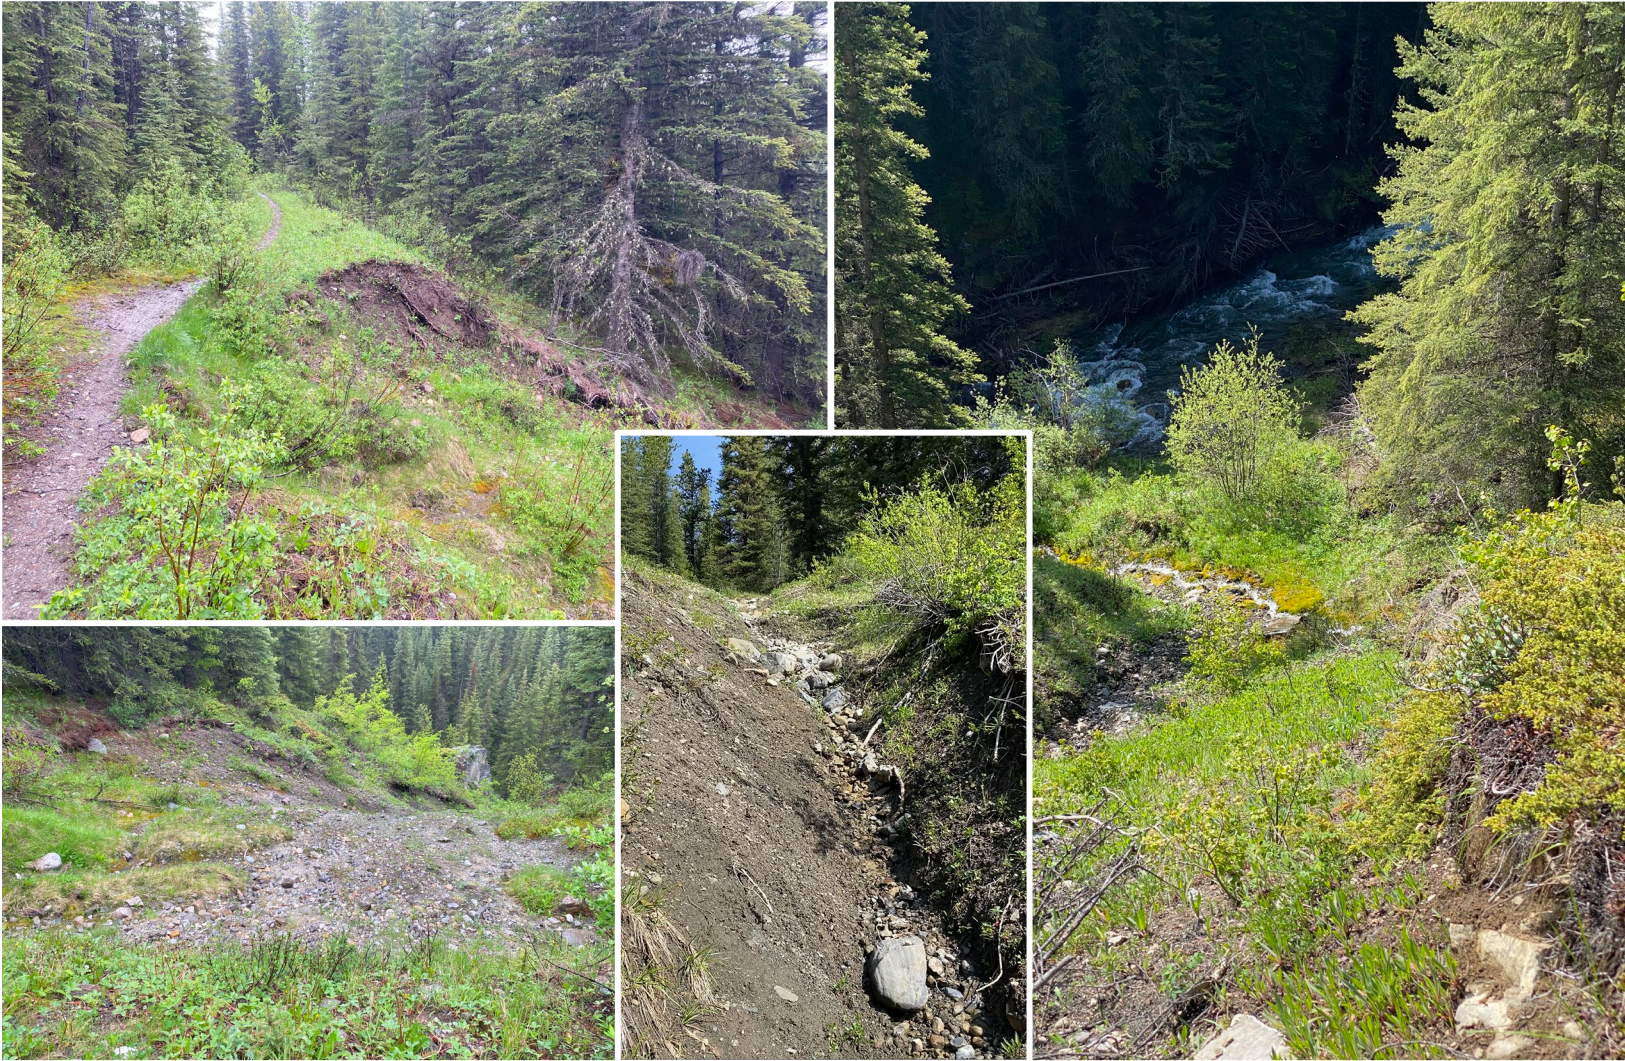
**Photo 21. Section of historical logging road situated on saturated soils that slid into Loomis Creek.**

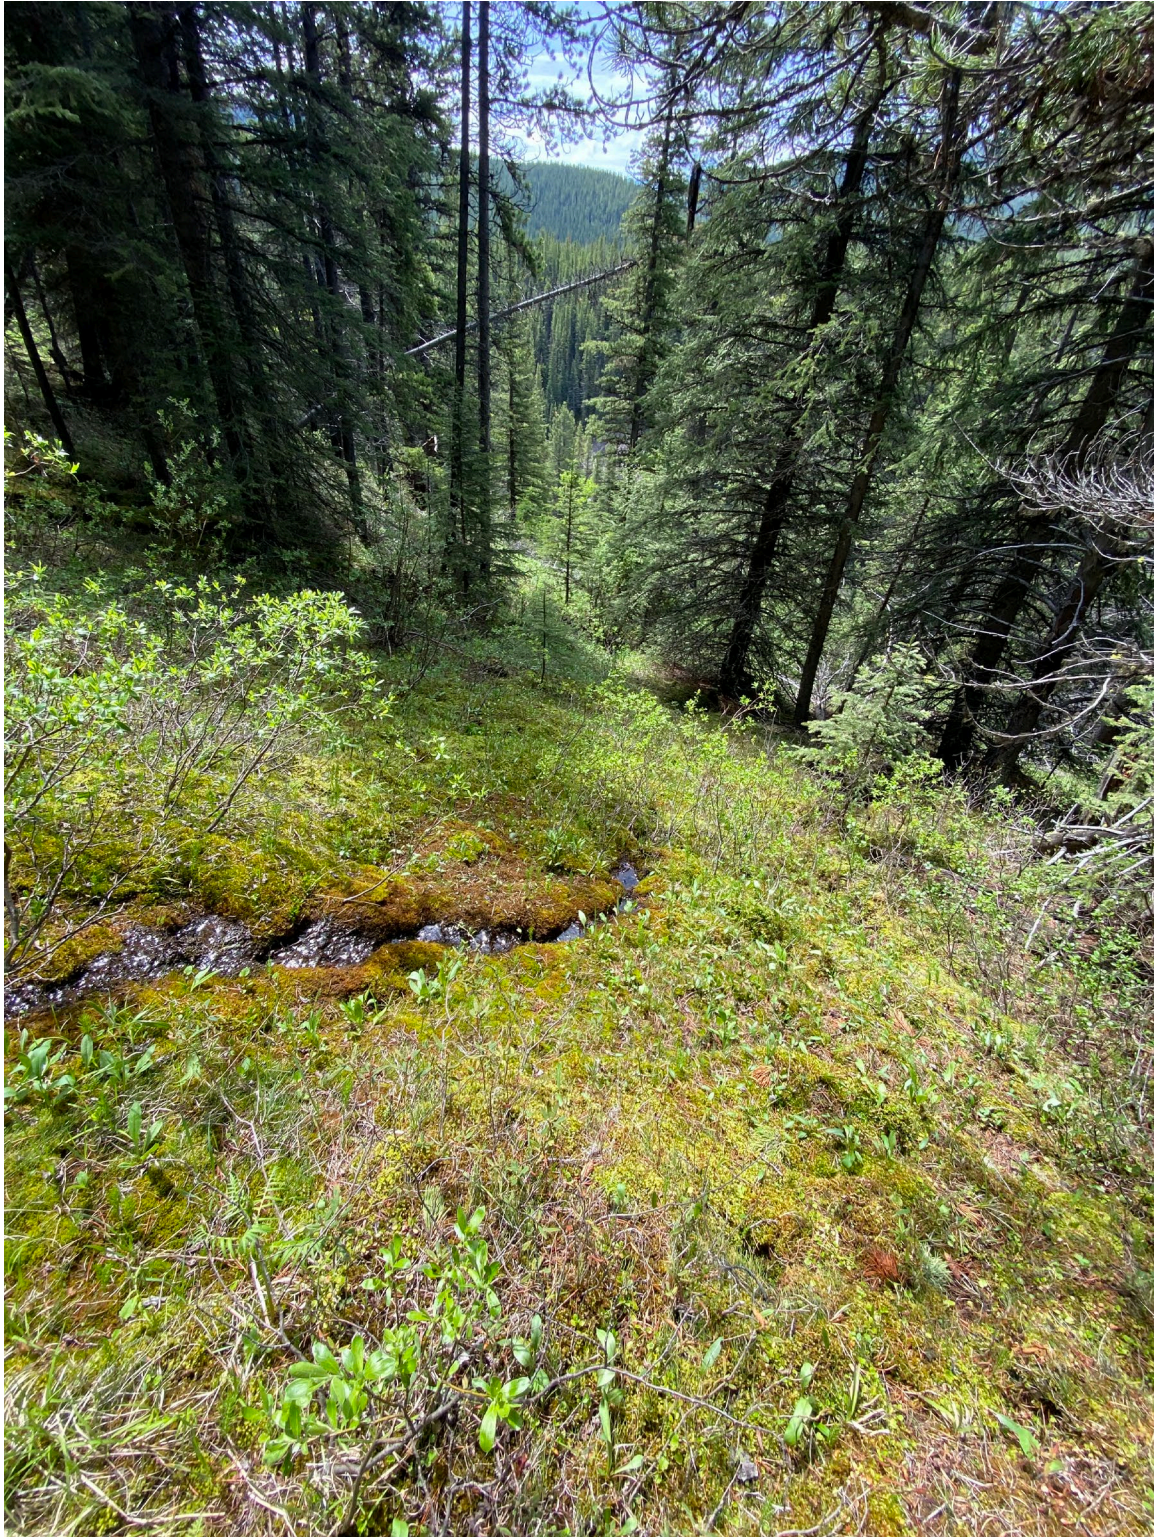
**Photo 22. Steep slope with saturated soils above Loomis Creek that the planned logging road crosses.**
