# Loomis Creek Eco-hydrology Phase 1 Study: 2024-2025

May 27, 2025

Fintegrate file #: 2025-CPAWS-01

**Prepared for:**

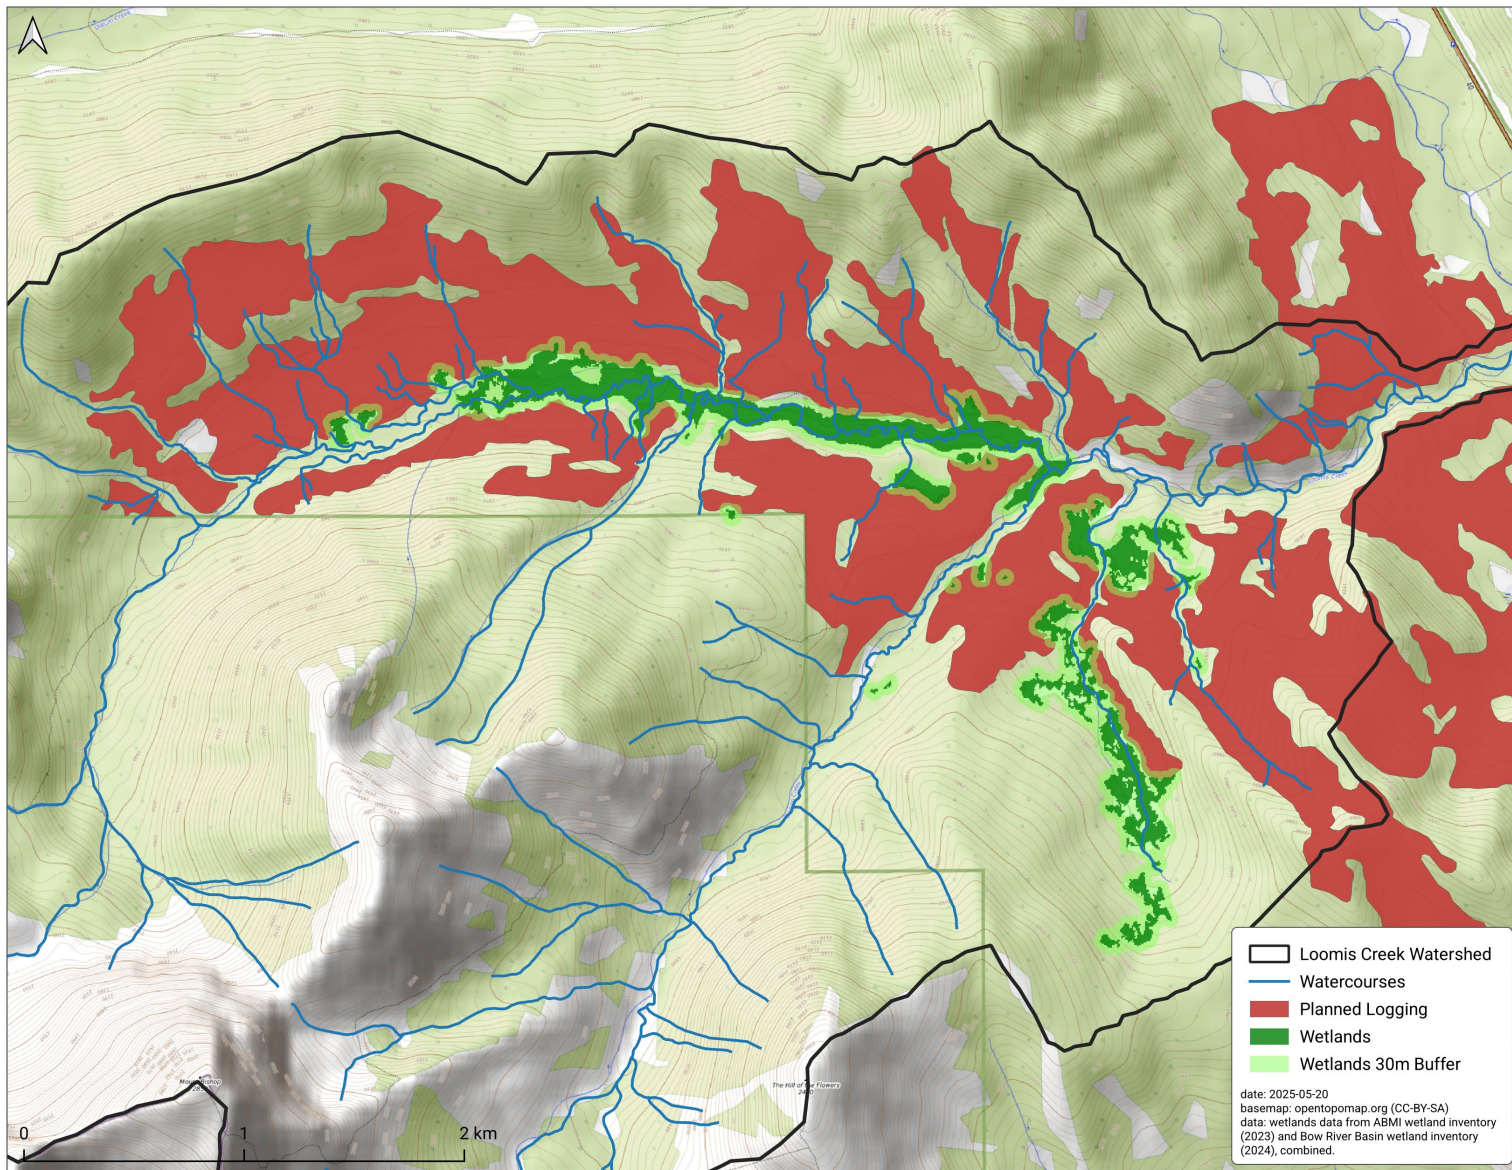
**Figure 34. Planned logging overlapping or within 30 m of areas mapped as wetlands.**

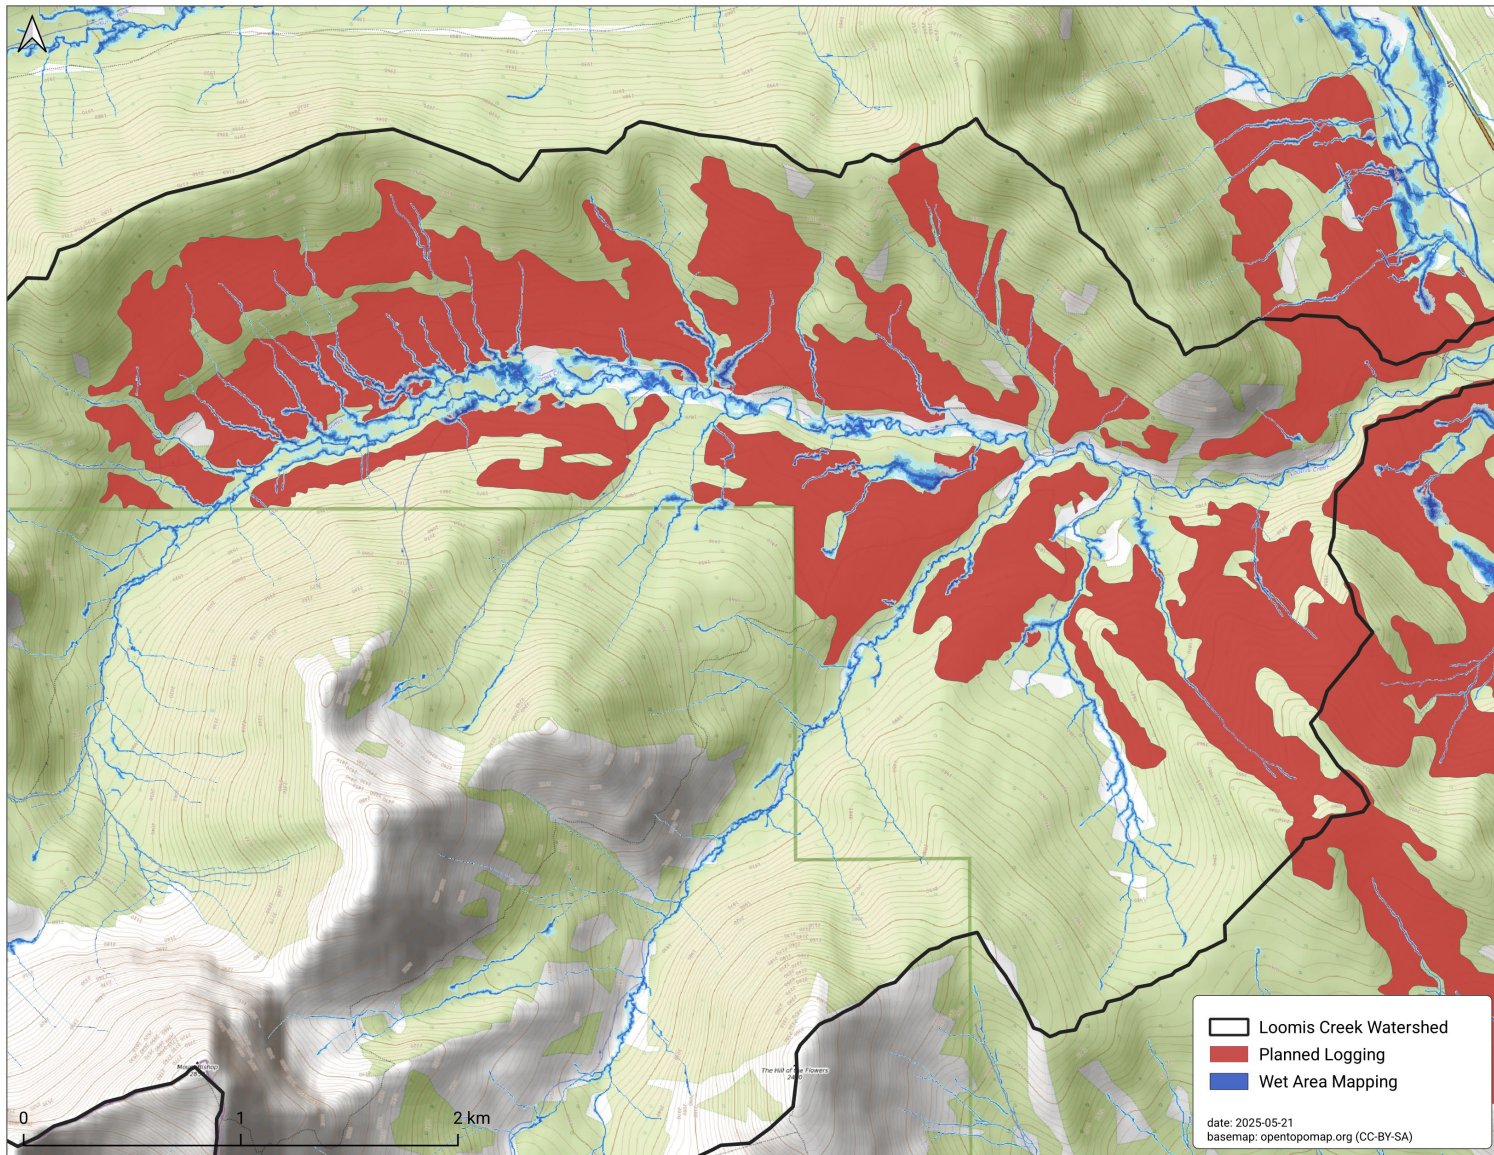
**Figure 35. Planned logging overlapping parts of the provincial Wet Area Mapping layer.**

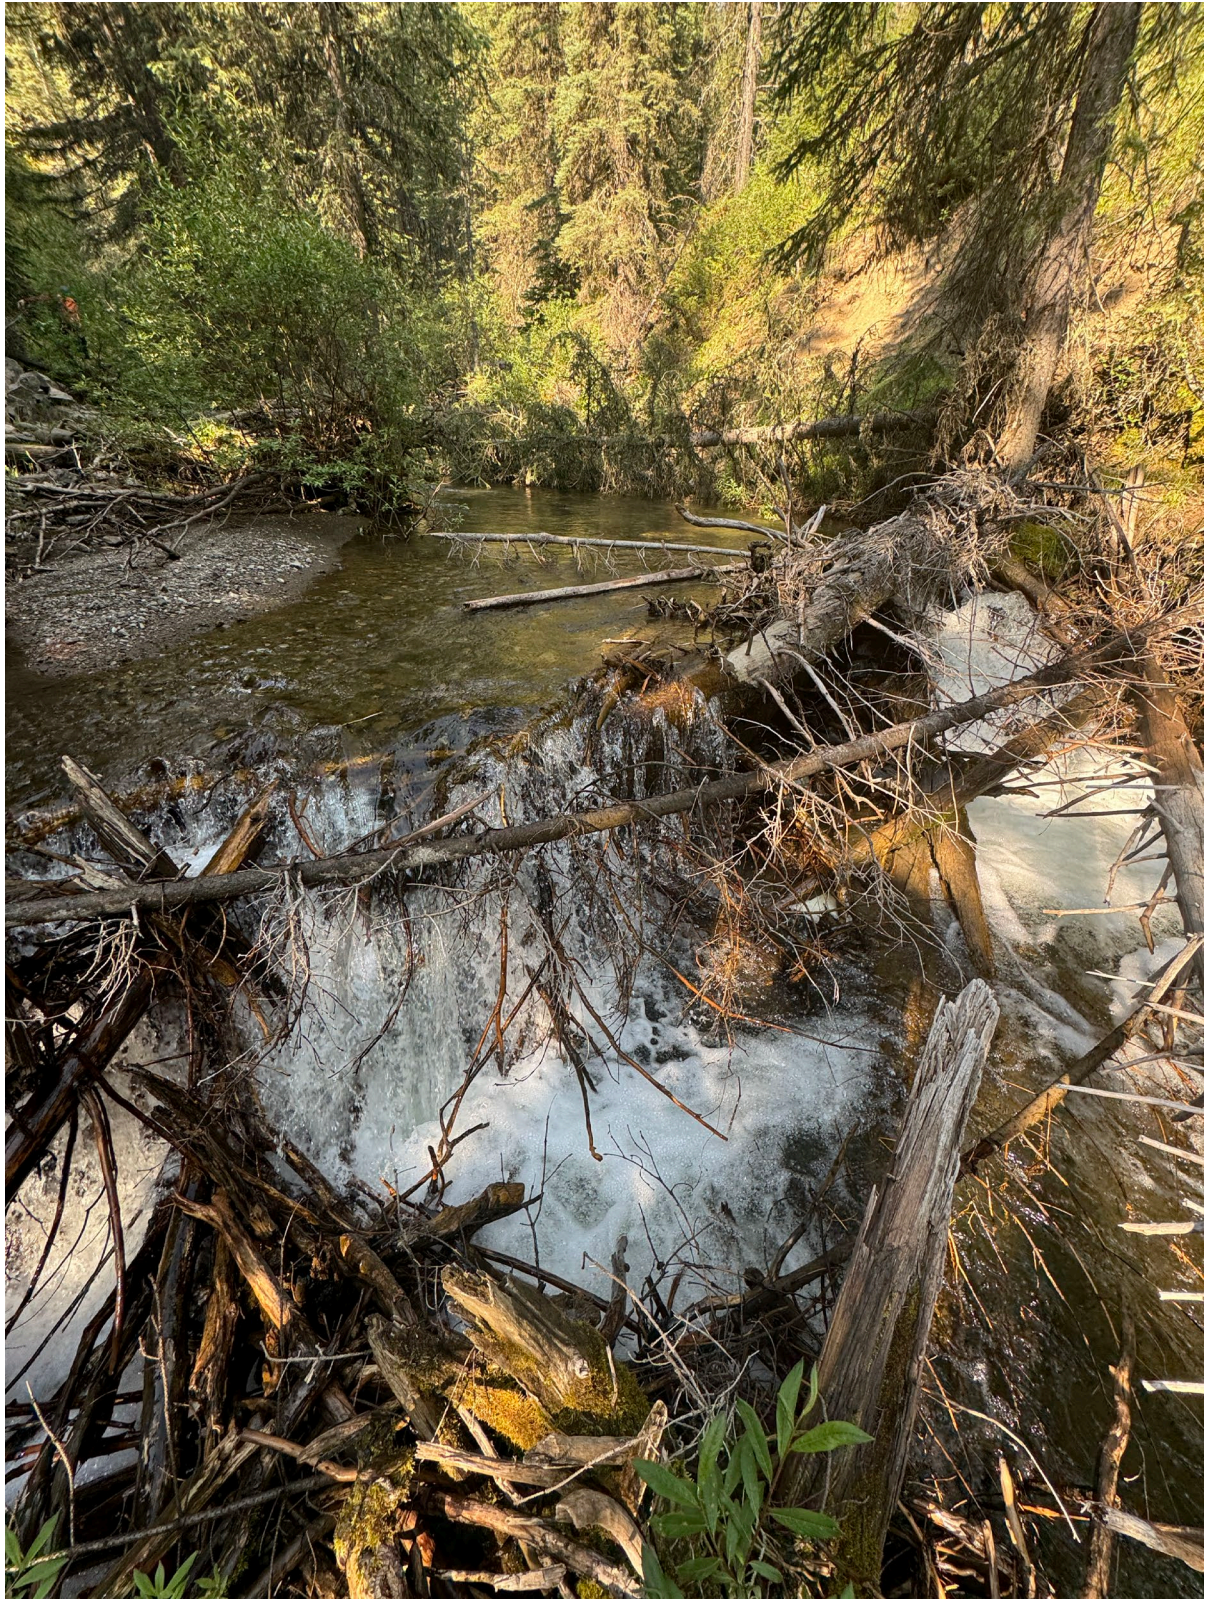
**Photo IV- 5. Forced step on lower Loomis Creek is a 1 m high barrier to upstream fish passage.**

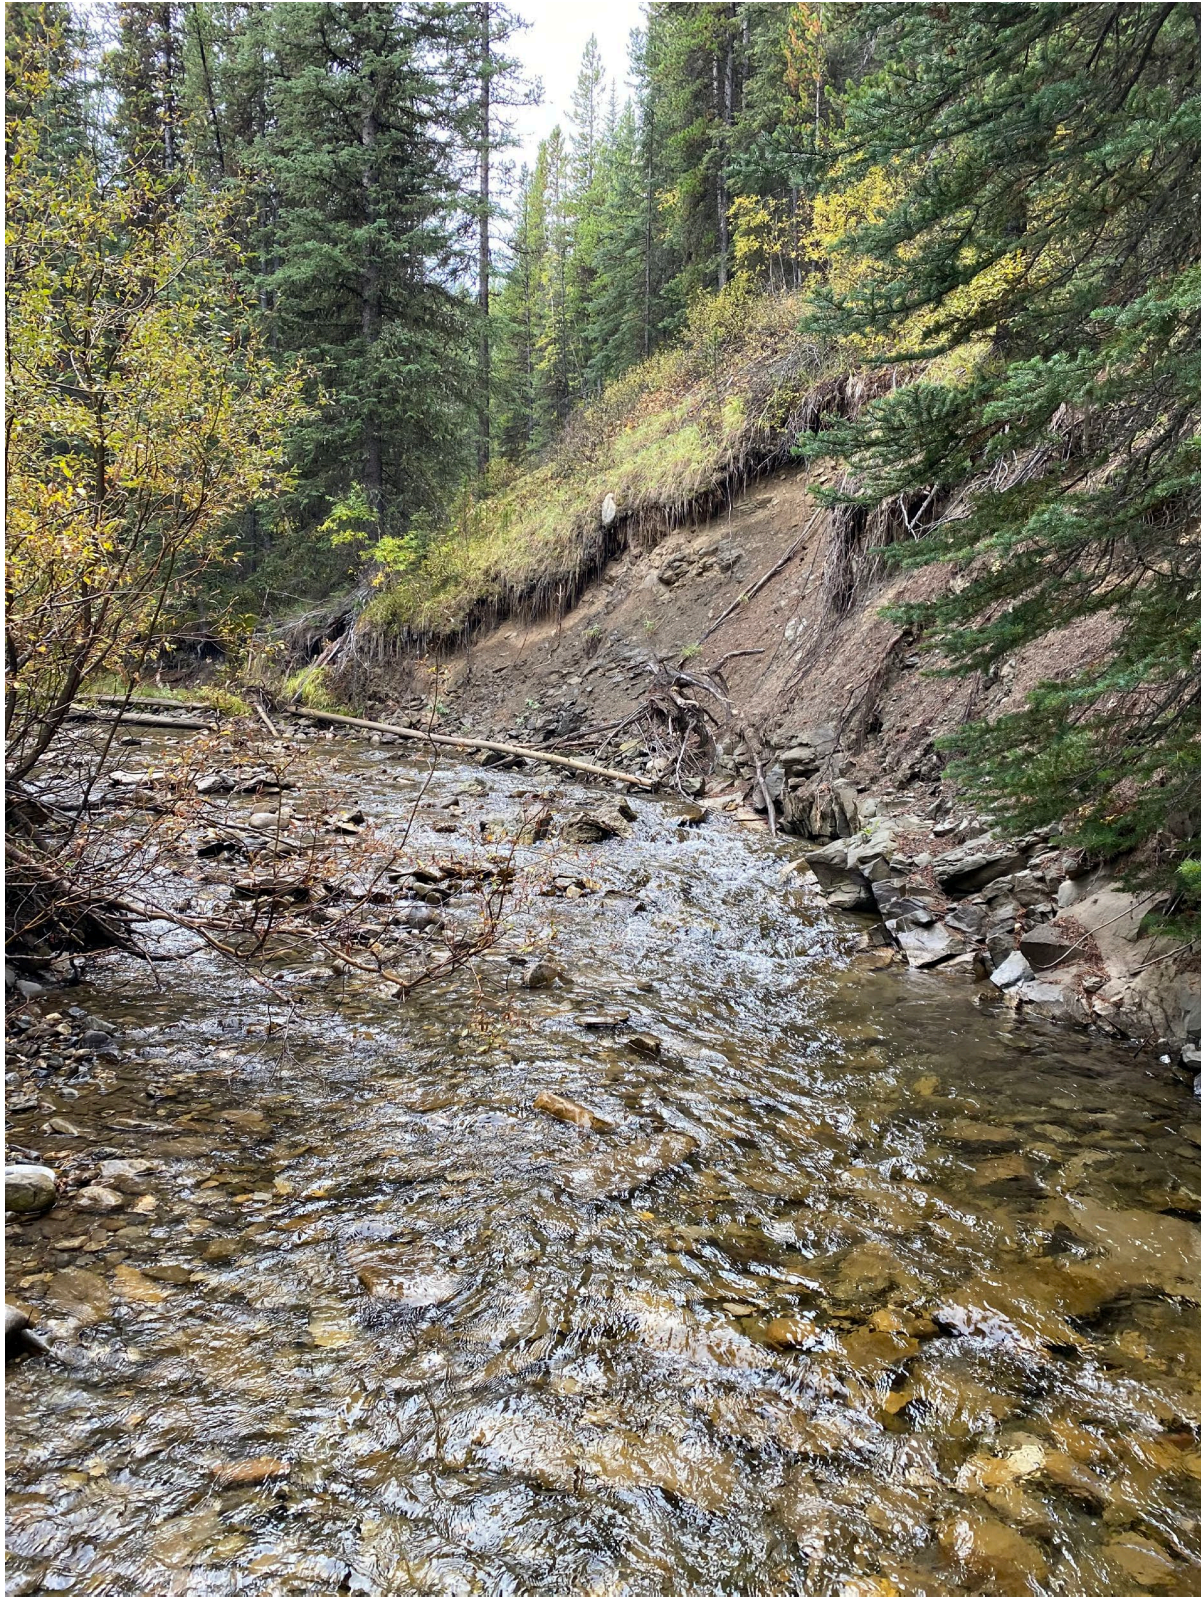
**Photo IV- 6. Eroding bank escarpment on lower reaches of Loomis Creek.**

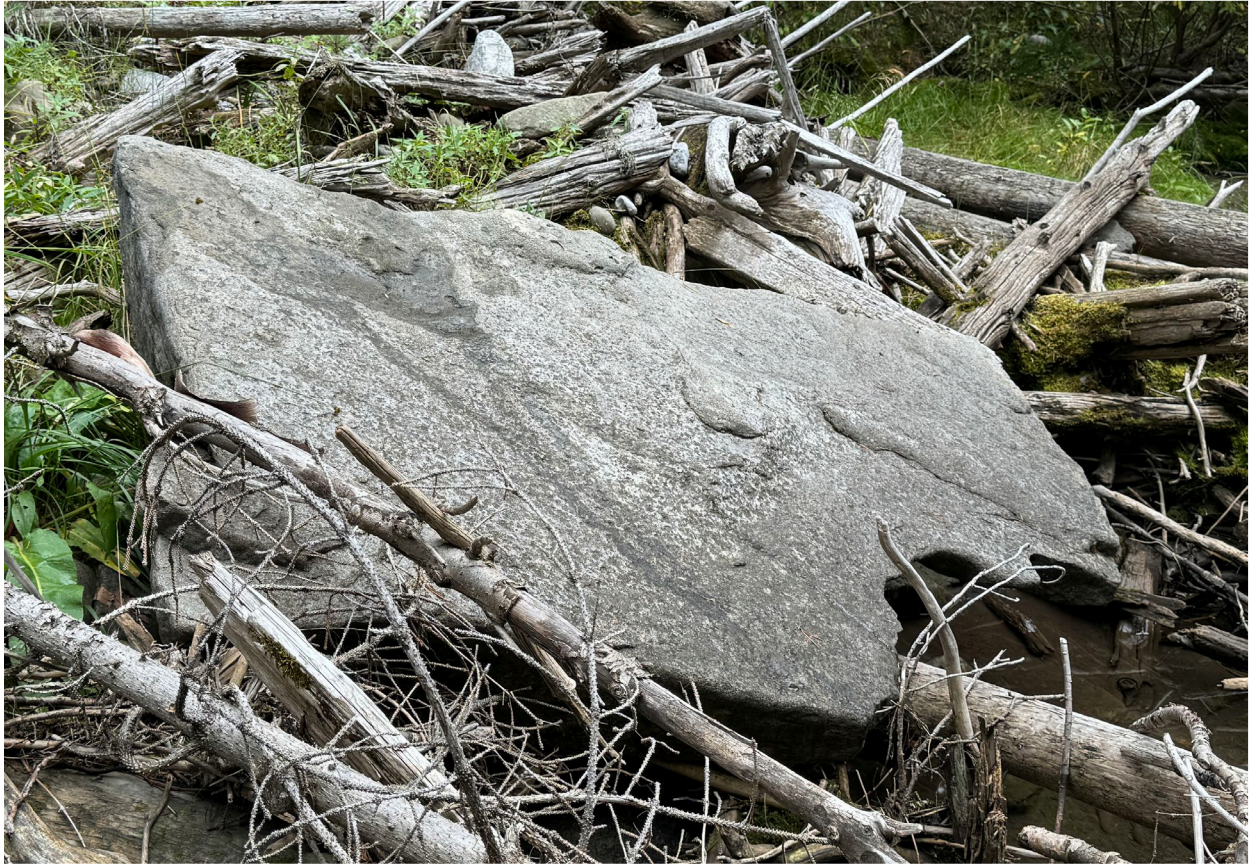
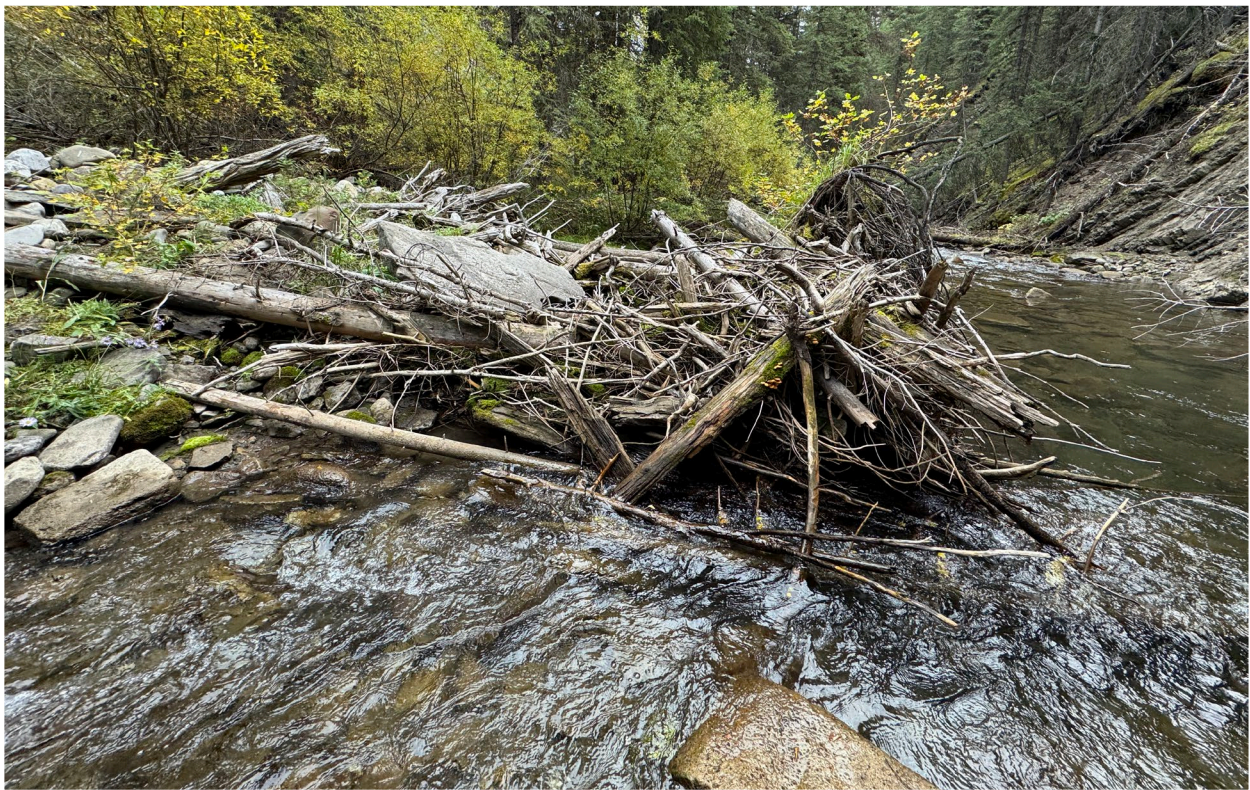
**Photo IV- 7. 2013 mobile bedload with intermediate axis ~60 cm near mouth of Loomis Creek.**

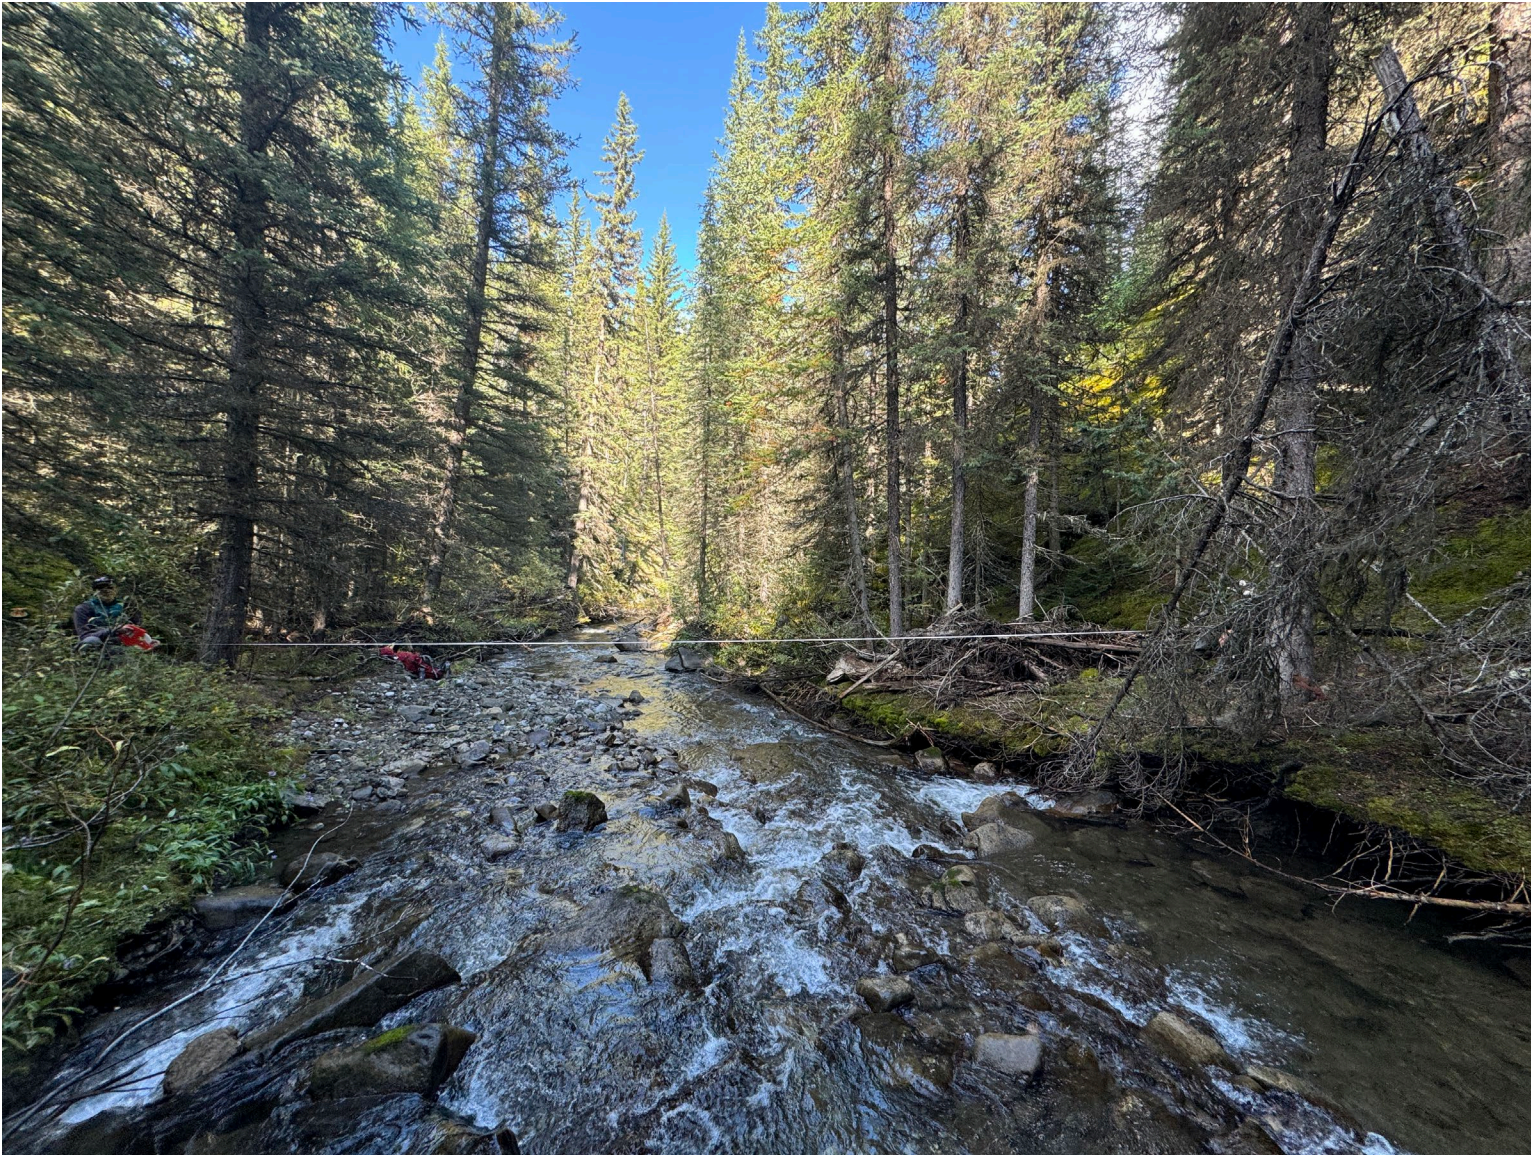
**Photo IV- 8. Flood sign height on the lower reaches of Loomis Creek at CM34.**

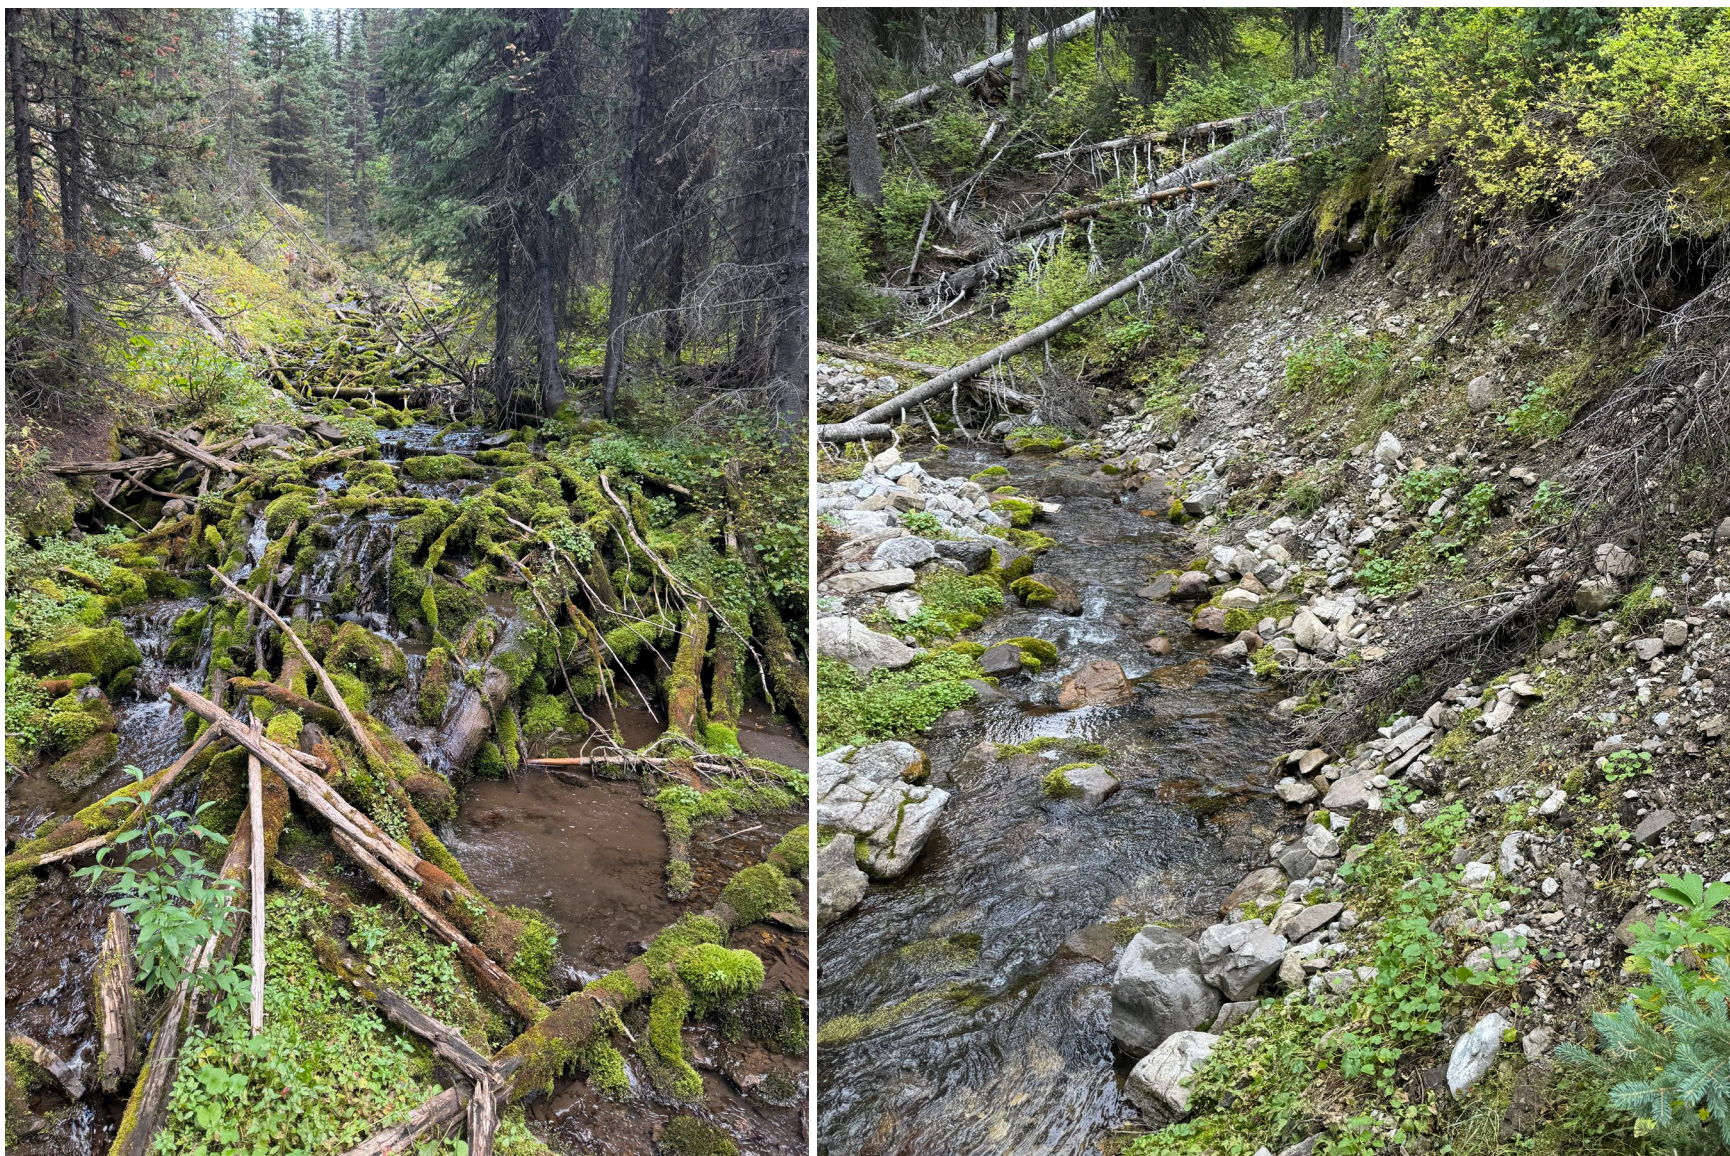
**Photo IV- 9. Headwater tributary avalanche sign with woody debris (CM03, western) and slush-caused bank scour (CM01, eastern).**

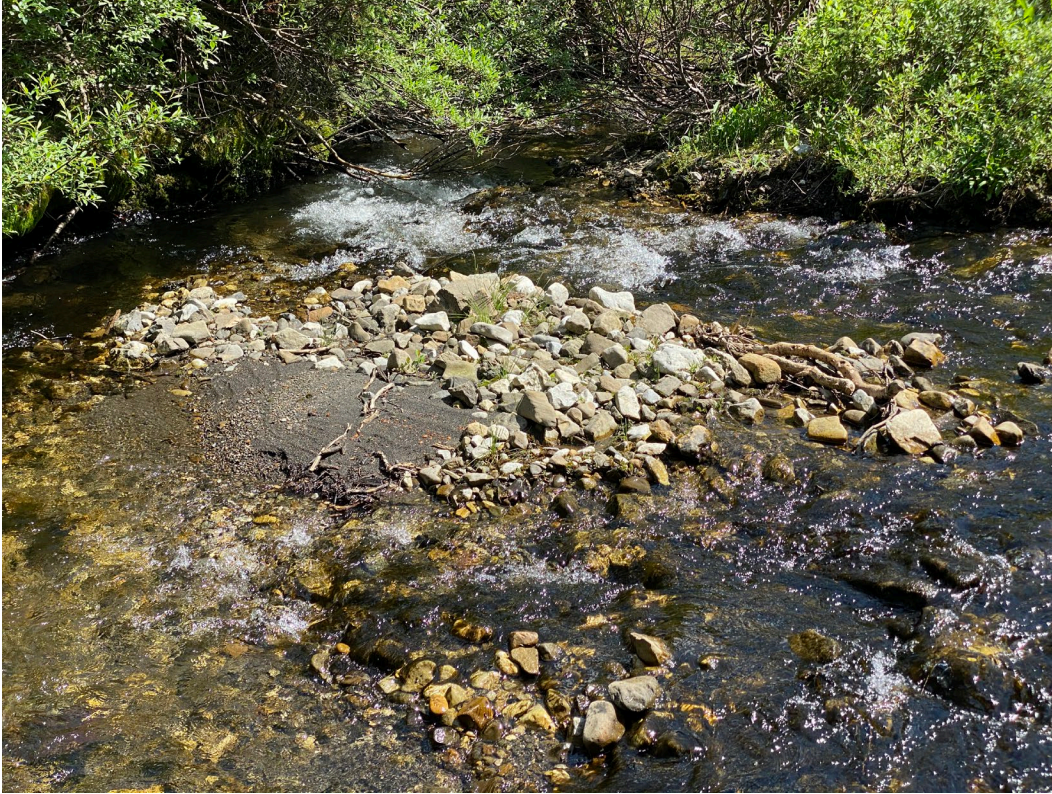
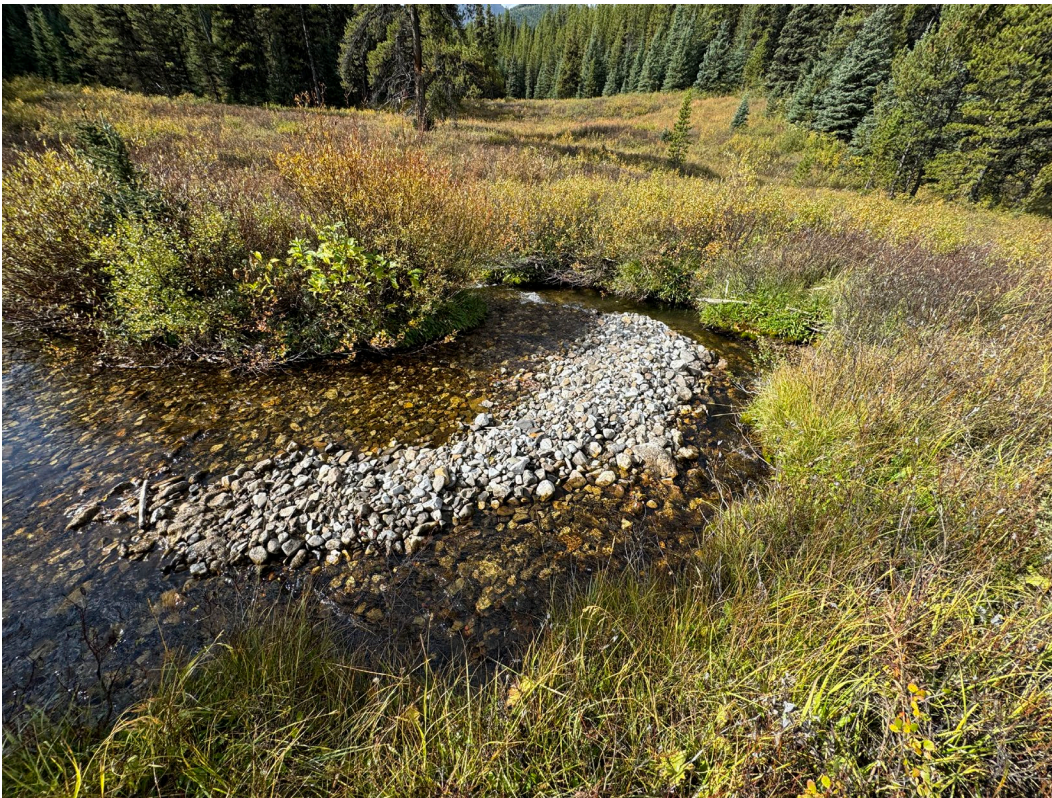
**Photo IV- 10. Bishop Creek mid channel gravel bar deposits from past flood events.**

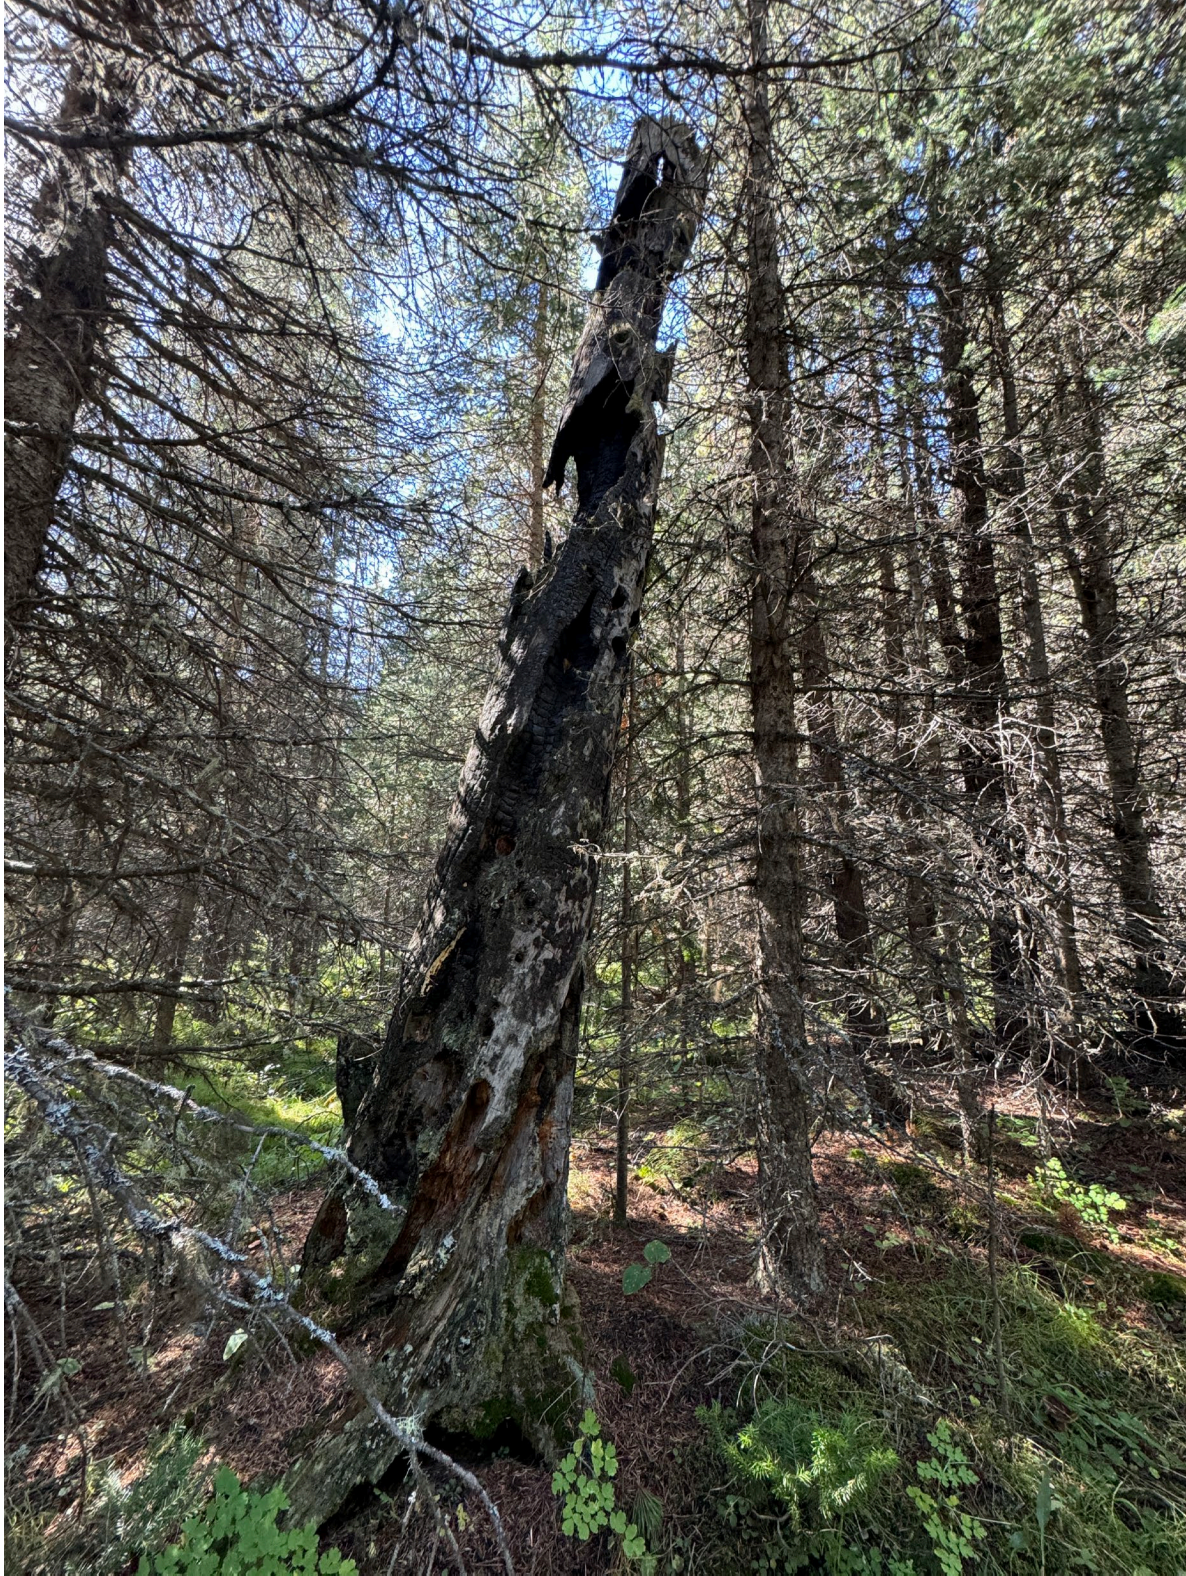
**Photo IV- 13. Evidence of historical fire in LSBN4 showing small size of regenerating stand.**
