# Loomis Creek Eco-hydrology Phase 1 Study: 2024-2025

May 27, 2025

Fintegrate file #: 2025-CPAWS-01

**Prepared for:**

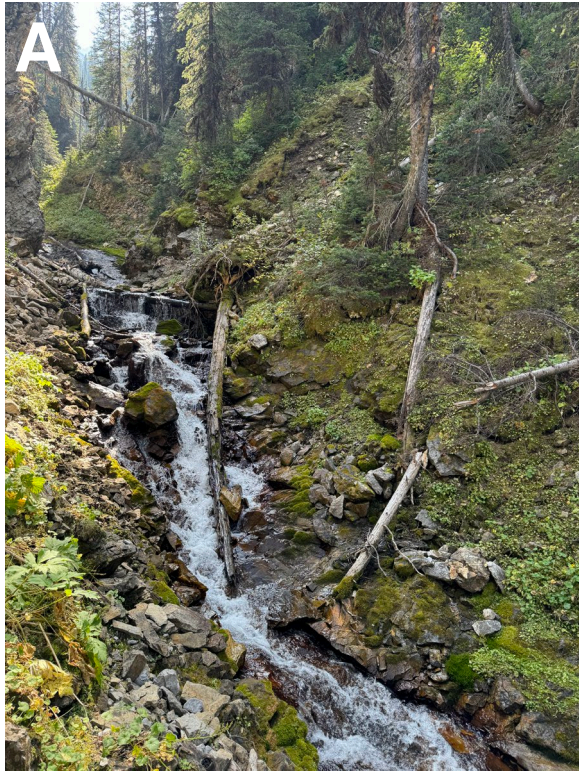
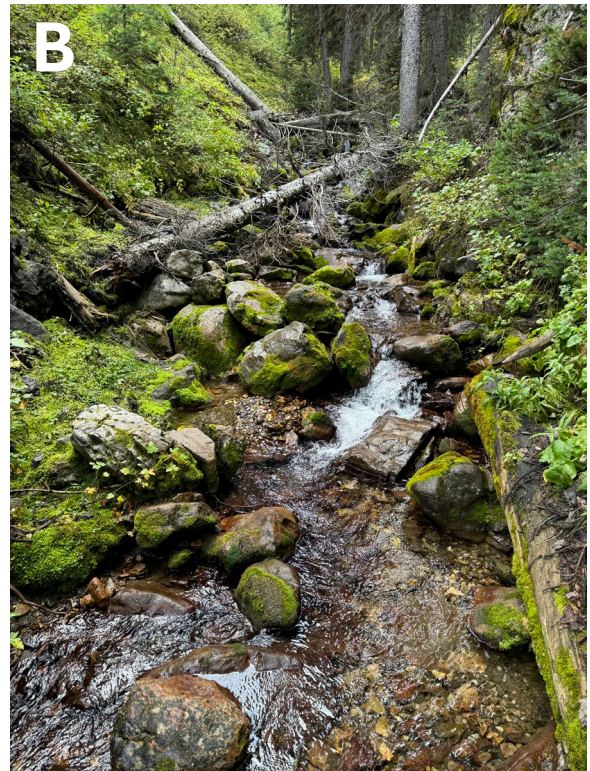
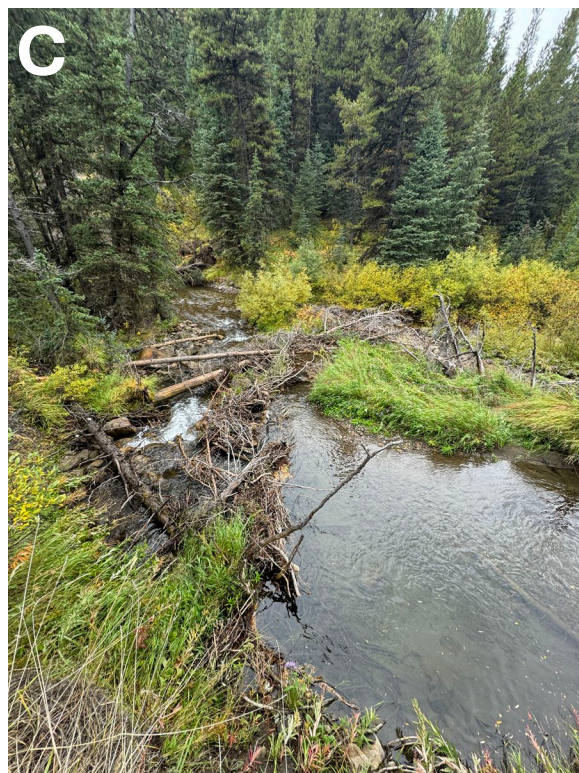
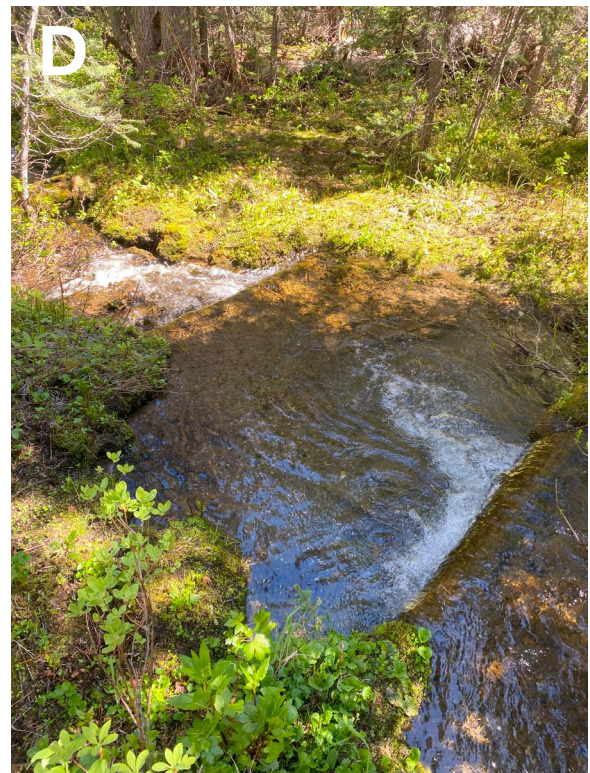
**Photo 3. Morphology examples: colluvial (A: headwaters south), cascade boulder (B: LSBN9), forced riffle pool (C: Loomis mainstem), forced step pool (D: LSBN8).**

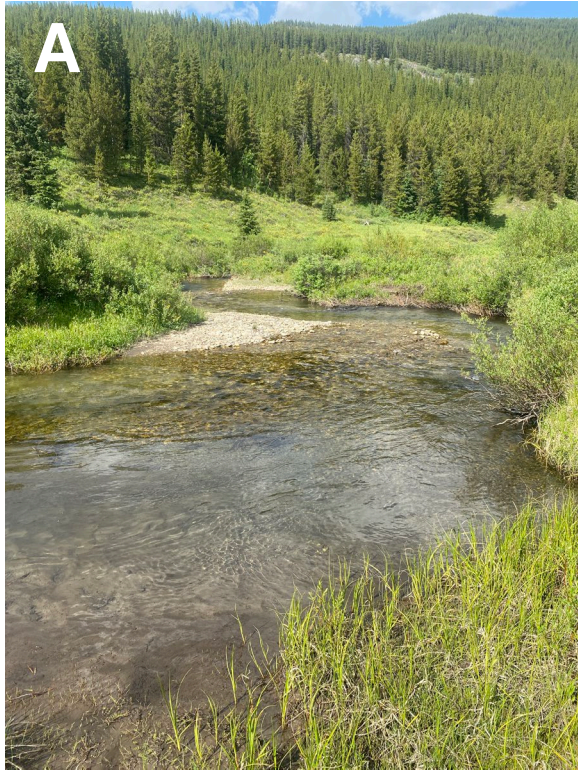
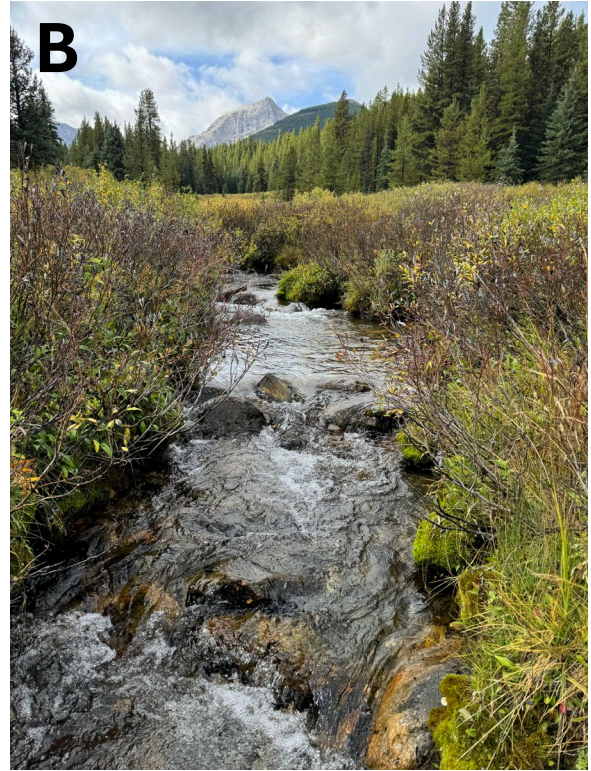
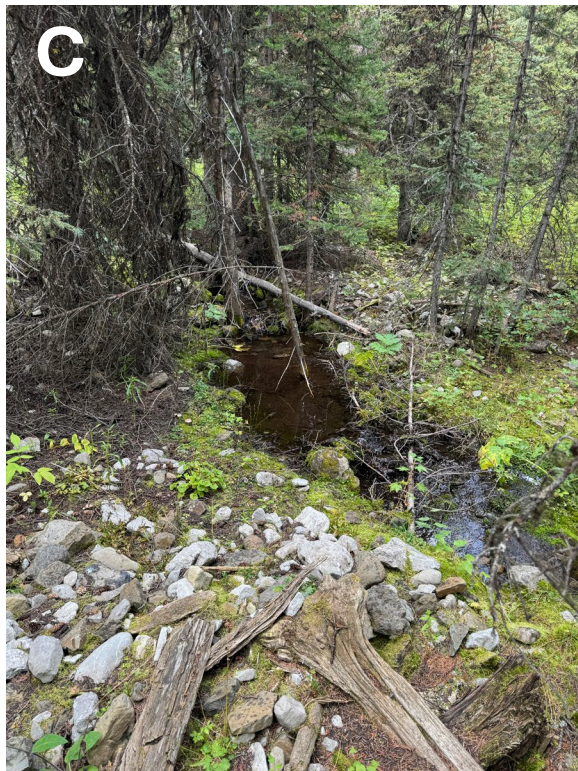
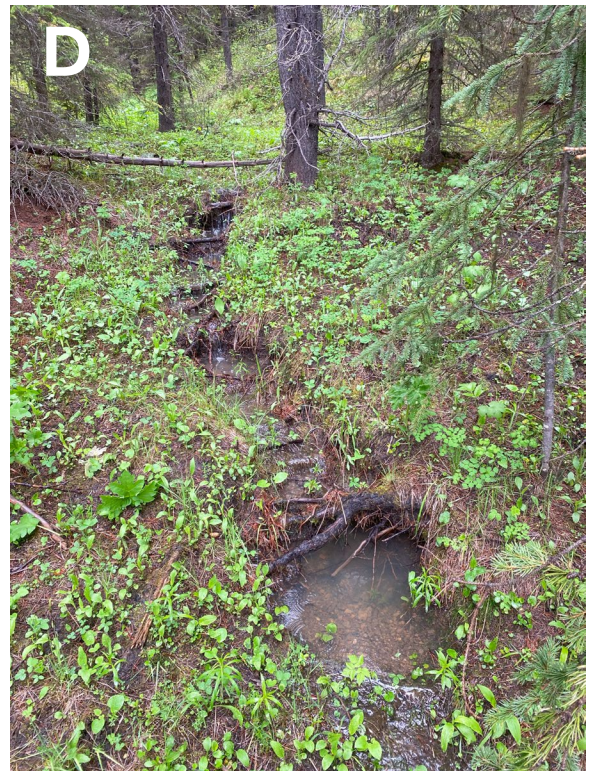
**Photo 4. Morphology examples: riffle pool (A: Loomis mainstem), step pool (B: Bishop at mouth), overflow channel (C: old LSBN9 channel), and intermittent (D: LSBN3).**

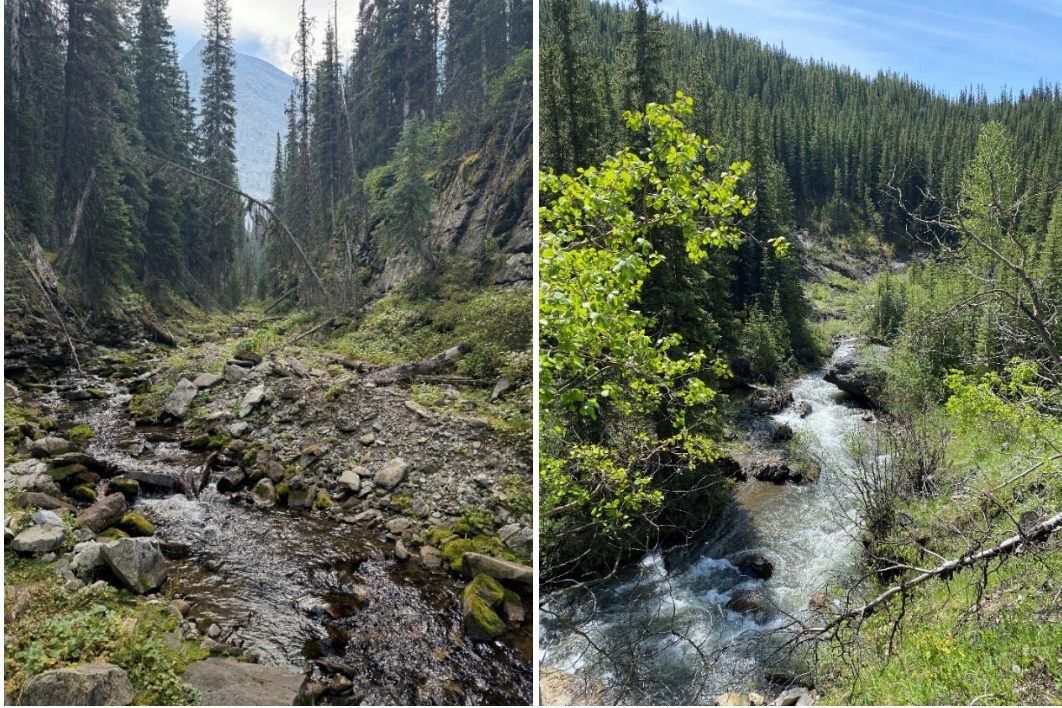
Both the headwaters and lower reaches of Loomis Creek are confined by bedrock walls and steep valley escarpments with no floodplain in some sections or a narrow floodplain in others (**Photo 5**). Where a floodplain is present, the channel is incised from the 2013 event and Loomis Creek does not overtop the floodplain in typical 1-2 year highwater events.

**Photo 5. Loomis Creek in headwaters (left) and lower reaches at Boulder Crossing (right), both showing high gradient, steep valley, lack of an active floodplain.**

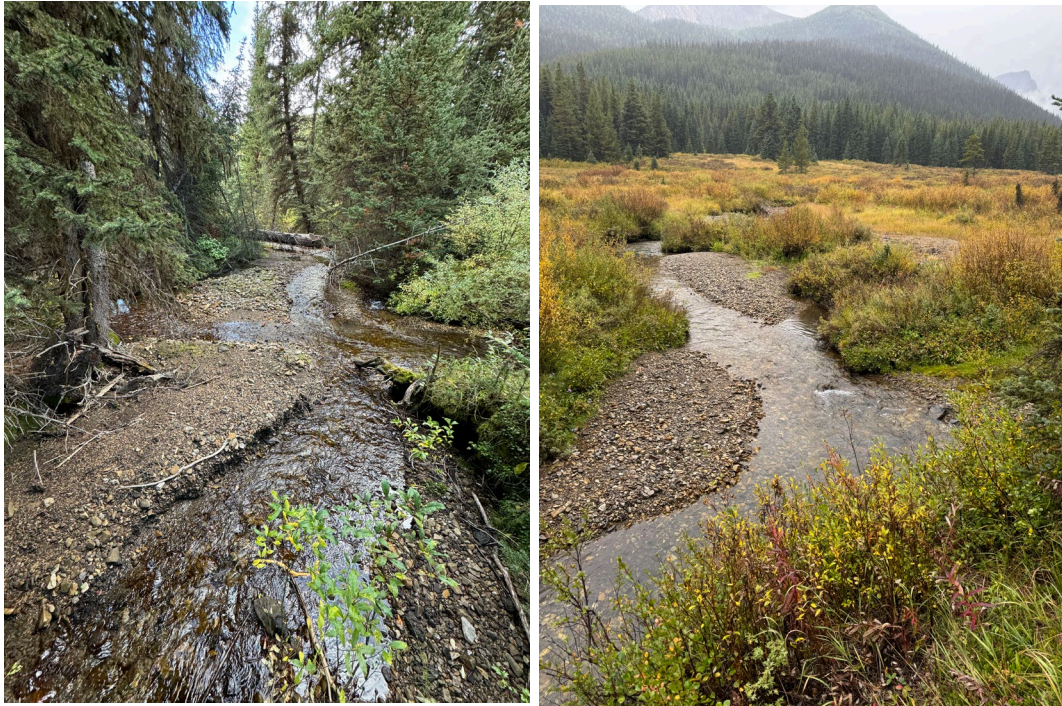
In contrast, the mid reach of Loomis Creek flows through a broad floodplain that is forested upstream of the beaver meadows and unforested within the beaver meadows (**Photo 6**). The floodplain is also not overtopped in typical 1-2 year highwater events and was formed during the last glacial retreat. The beaver meadows have formed over centuries of beaver activity.

**Photo 6. Low gradient, mid reach of Loomis Creek above (left) and within (right) the beaver meadows.**

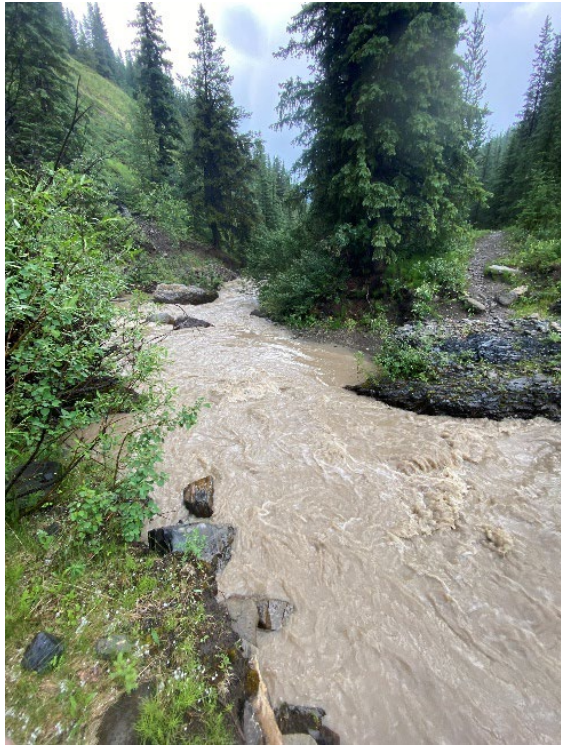
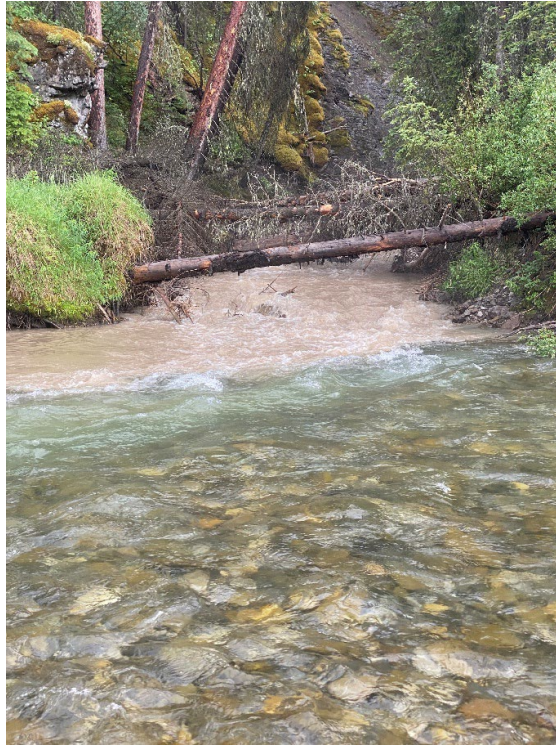
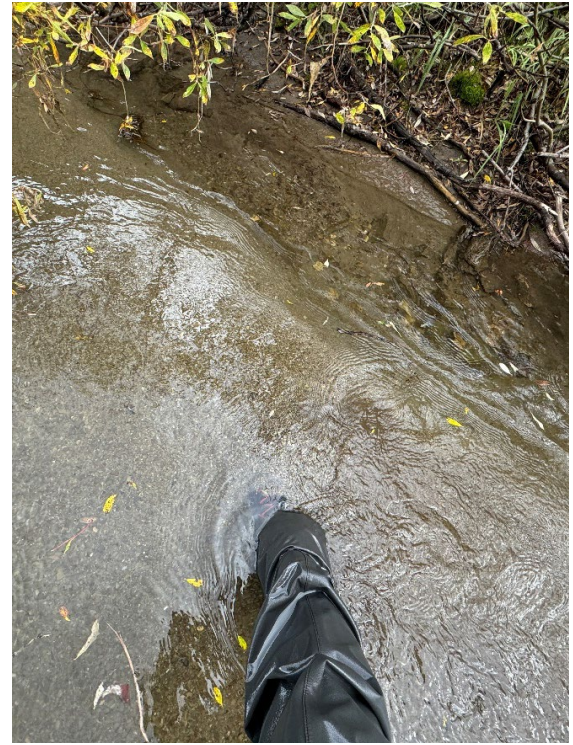
One large point source of ongoing sediment inputs to Loomis Creek was observed approximately 350 m downstream of Bishop Creek where a steep valley escarpment on the North bank is actively eroding and releasing substantial amounts of fine gravel, sand, and silt during rainfall events (**Photo 7**). It is not known whether the bank escarpment was destabilized by flooding triggered by hydrologic changes following historical fire or logging, but it is evident on 1949 areal imagery and is not associated with historical logging road construction. Fine sediment from the site resulted in a pulse of TSS that reached the Highwood River on July 17, 2024, while fine gravel from the eroding escarpment is building up in Loomis Creek immediately downstream of the site (**Photo 8**).

**Photo 8. Turbidity in Loomis Creek from eroding bank escarpment at Boulder Crossing and discharging to the Highwood River; fine gravel from escarpment accumulating in Loomis Creek immediately downstream from escarpment.**

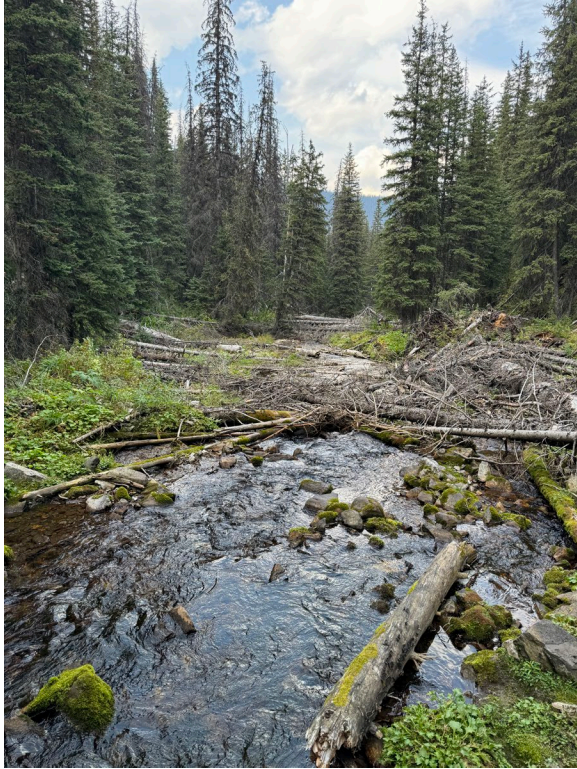
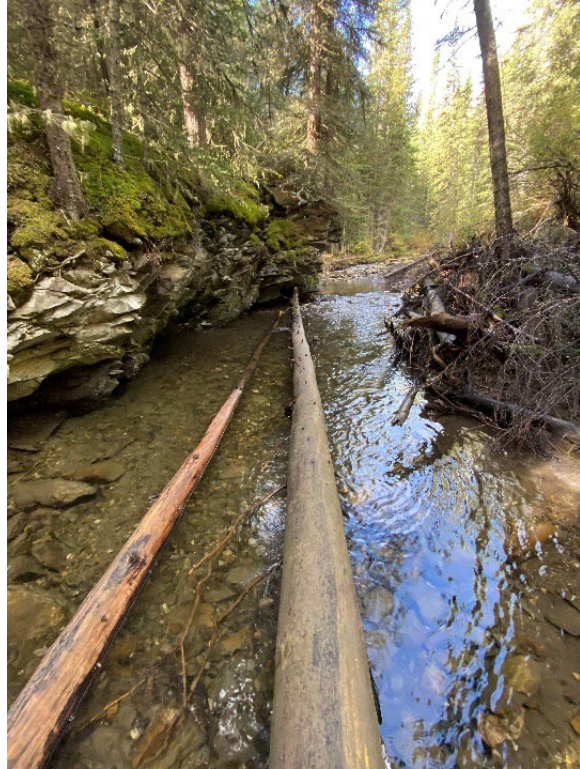
**Photo 9. LWD in Loomis Creek headwaters (left) and lower reaches (right).**

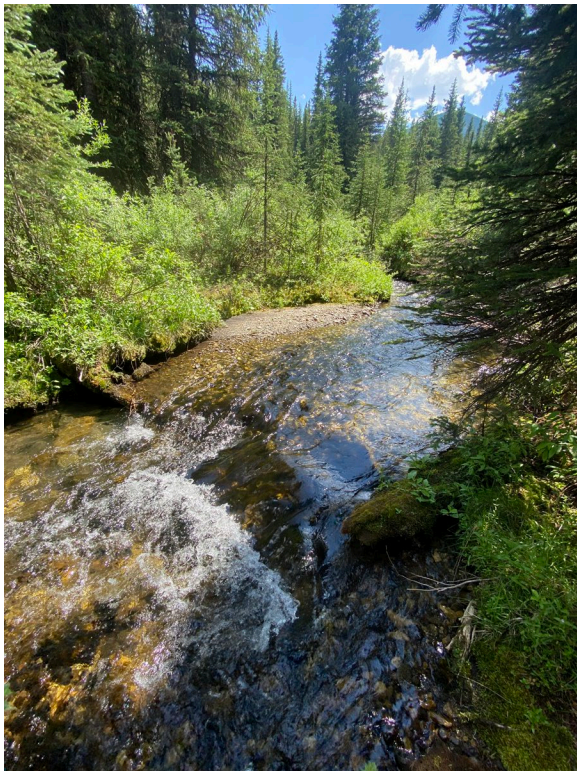
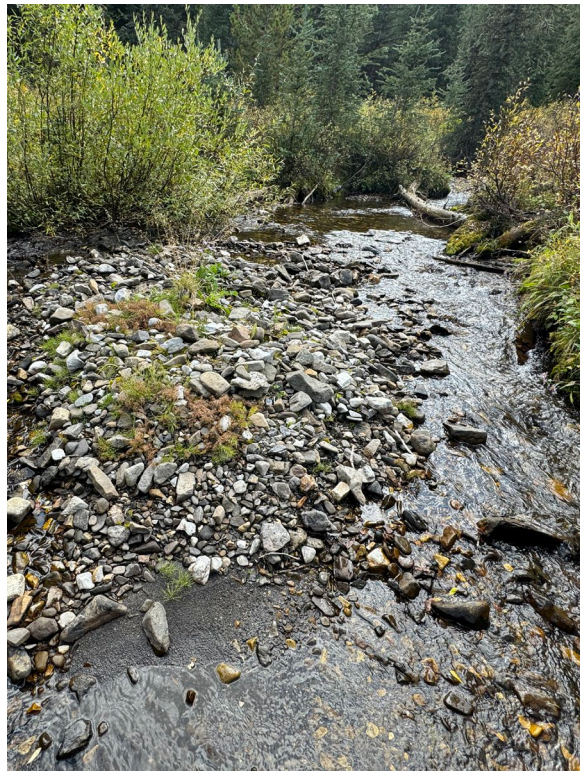
**Photo 10. Bishop Creek riffle-pool morphology common on the reach surveyed.**

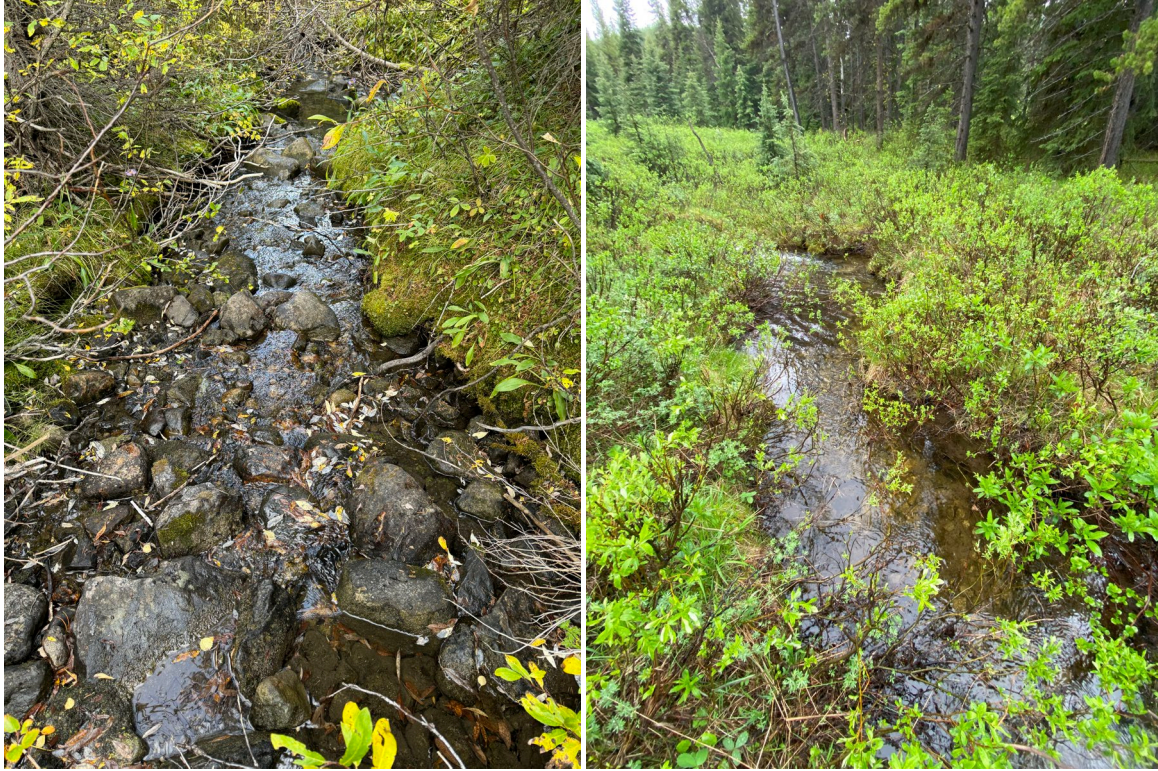
**Photo 11. LSBS2-3 cascade with boulders (left); upstream LSBS3 riffle pool (right).**

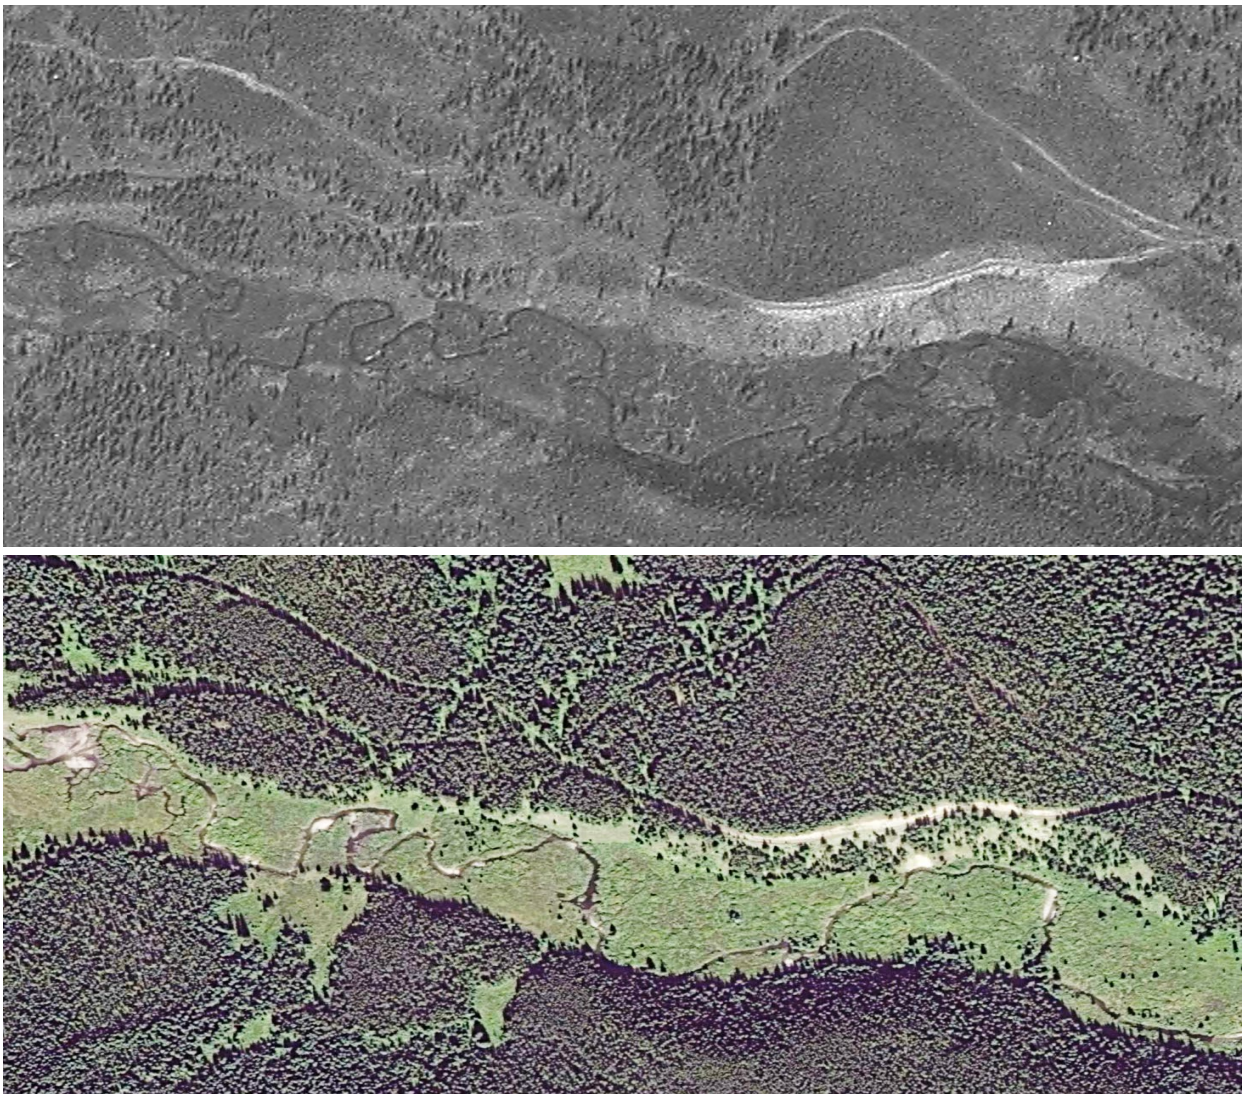
4. While areal photos show that the stream channel in the beaver meadows has remained relatively stable between 1949 and present (**Photo 23**), this habitat stability is not predicted to last with the hydrologic changes resulting from the logging. This is because the mid reach of Loomis Creek meanders over a broad floodplain of finer bedload material formed by glacial retreat and subsequent centuries of beaver activity. The entire stream bedload is already mobile under the current flow regime. Finer bedload material starts moving at 60% of bankfull flows and the amount of bedload movement increases as flows increase. The predicted increases in stream flow will result in more bedload movement as the D90 (cm) increases. Degradation and aggradation on the mainstem will be greater than has occurred under a natural disturbance regime.

**Photo 23. Comparison of historical (1949) and recent (2013) imagery of a section of Loomis Creek in the beaver meadows showing channel stability over 64 years.**

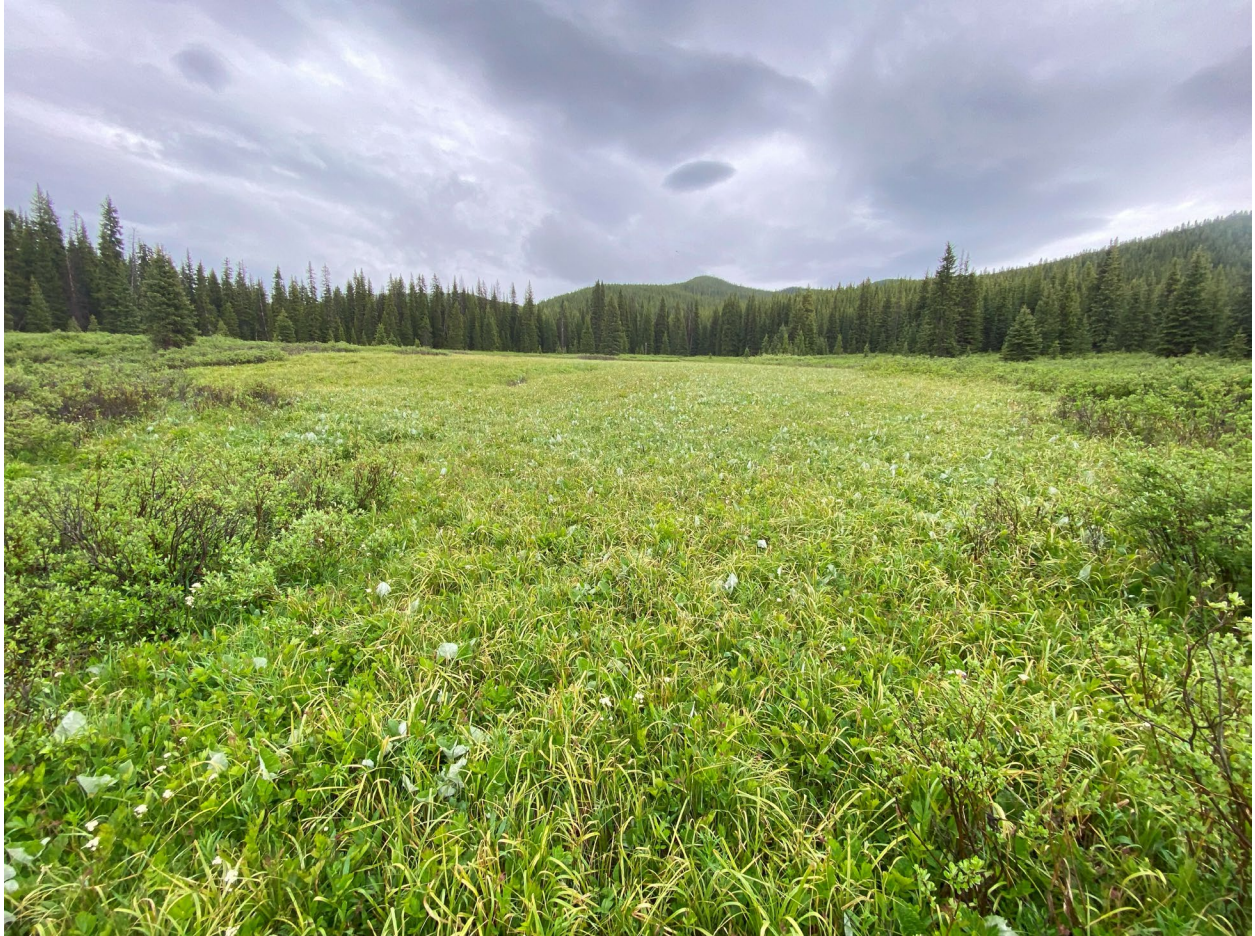
**Photo I- 1. Example of a potential fen in the LSBS2-3 subwatershed.**

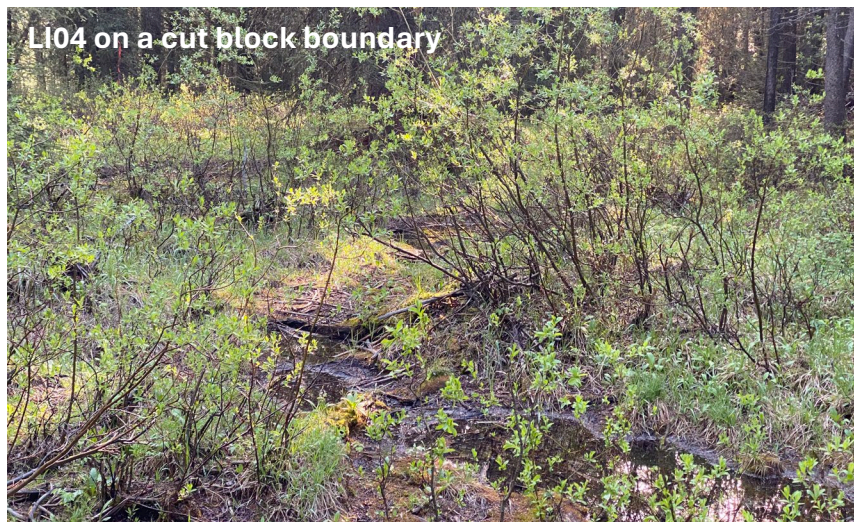
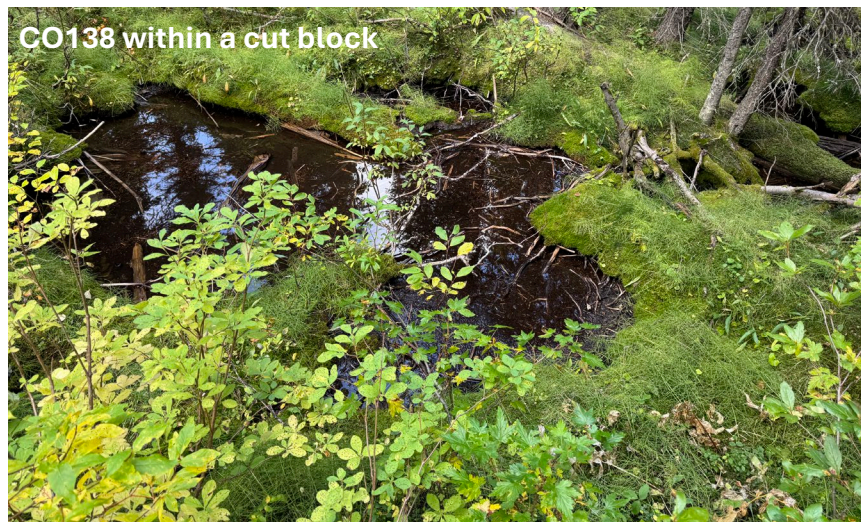
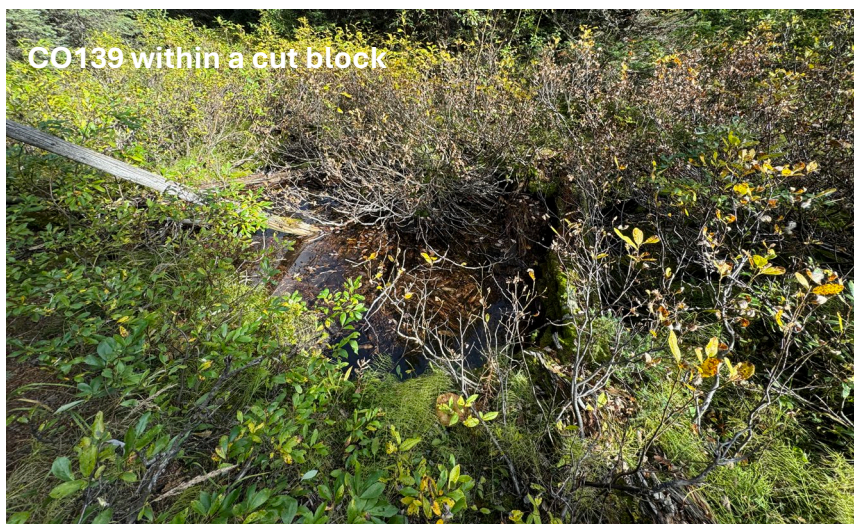
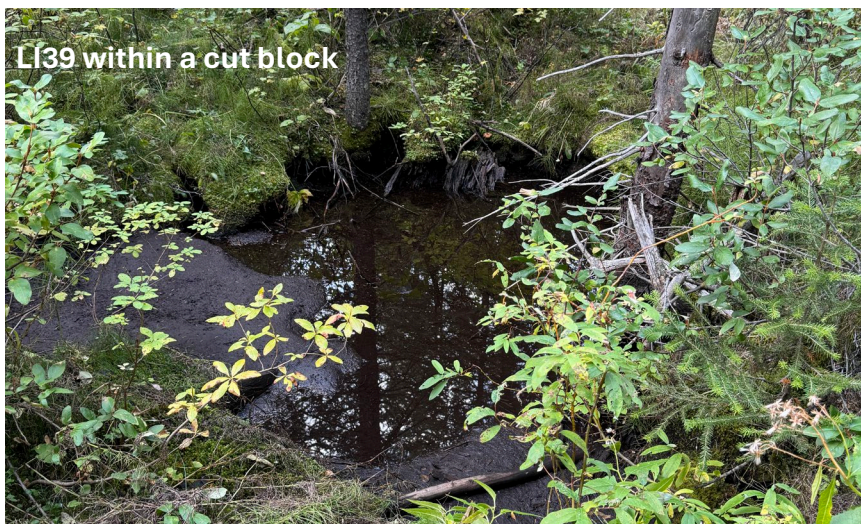
Wetland sites smaller than the fens described above occur throughout the Loomis Creek watershed, even at higher elevations. These areas may be permanently or semi-permanently wet if they are associated with groundwater discharge, or they may be temporary or seasonal groundwater recharge areas, with surface water only present for a short period of time after snowmelt or heavy rainfall (**Photo I- 2**).

Photo I- 2. Examples of small wetland sites within planned clearcut logging areas at the [Online Map](#) Site IDs shown.

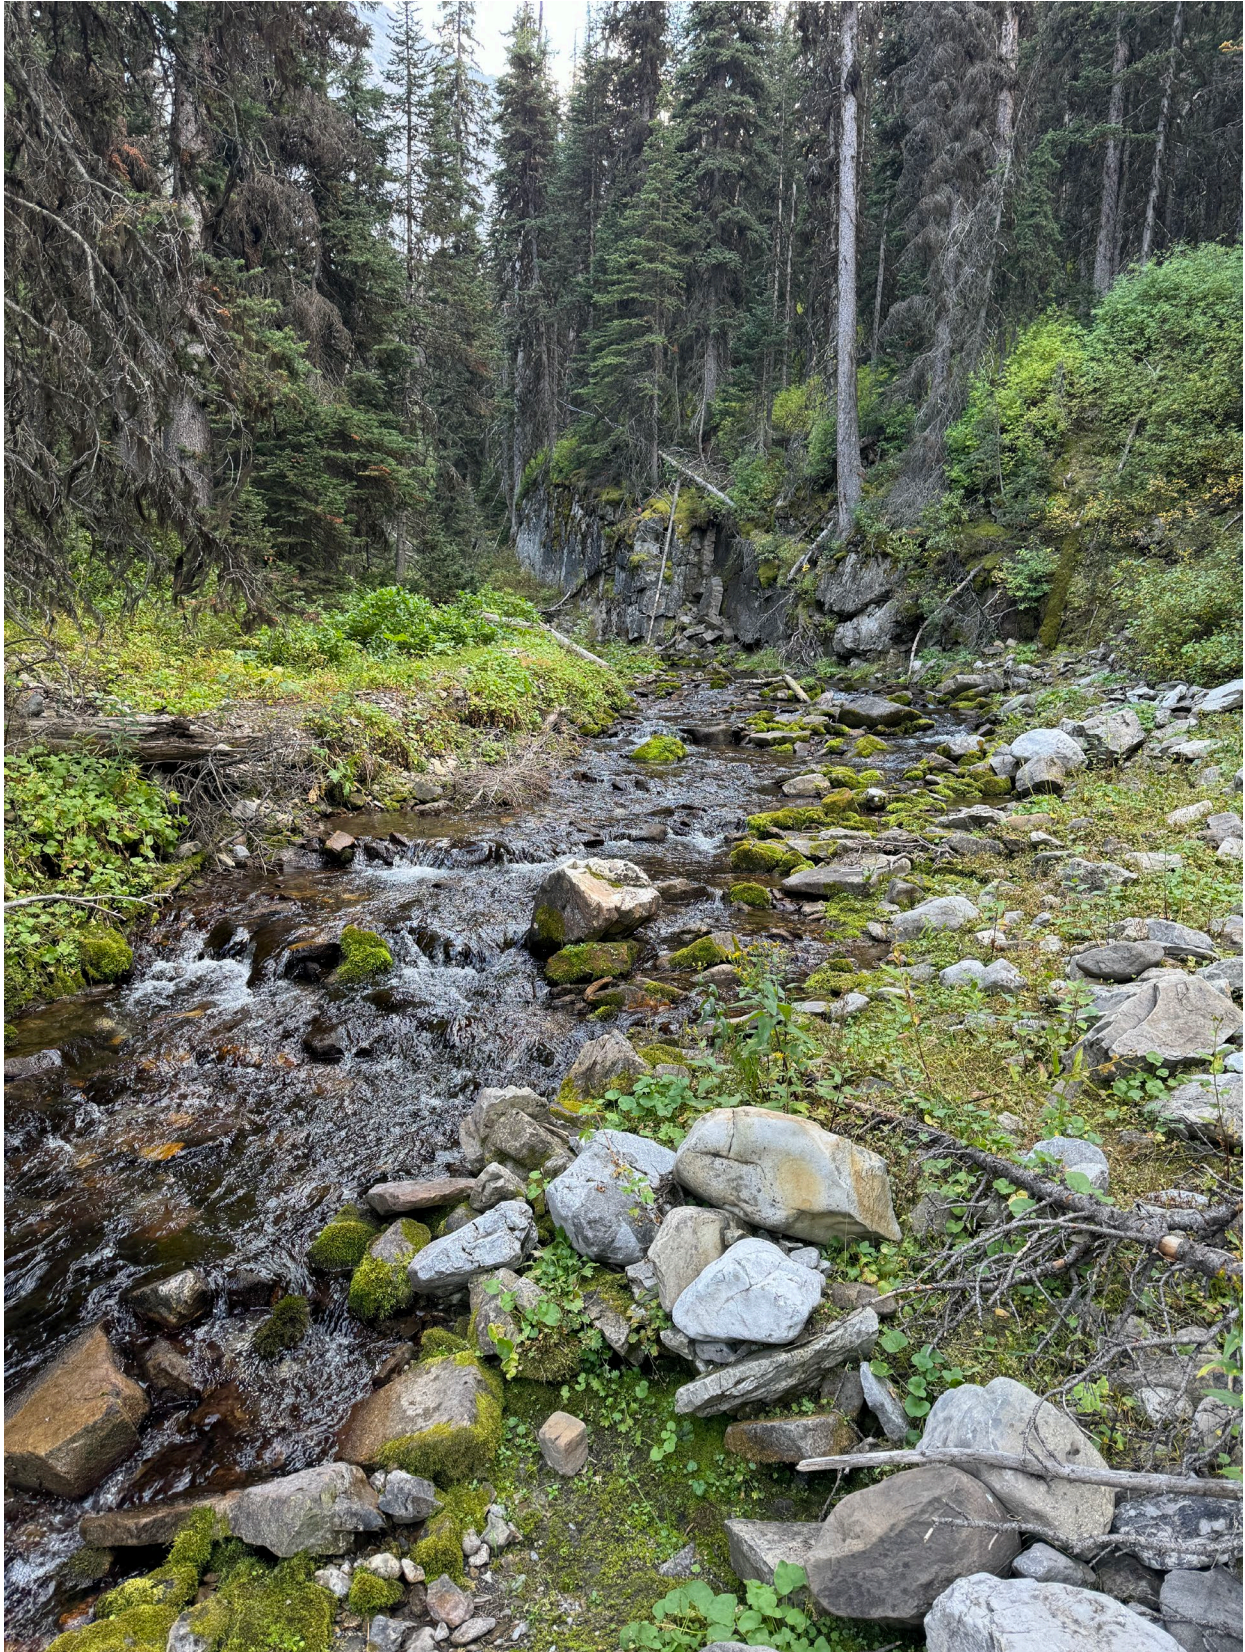
**Photo IV- 1. Loomis Creek headwaters cascade boulder channel morphology.**

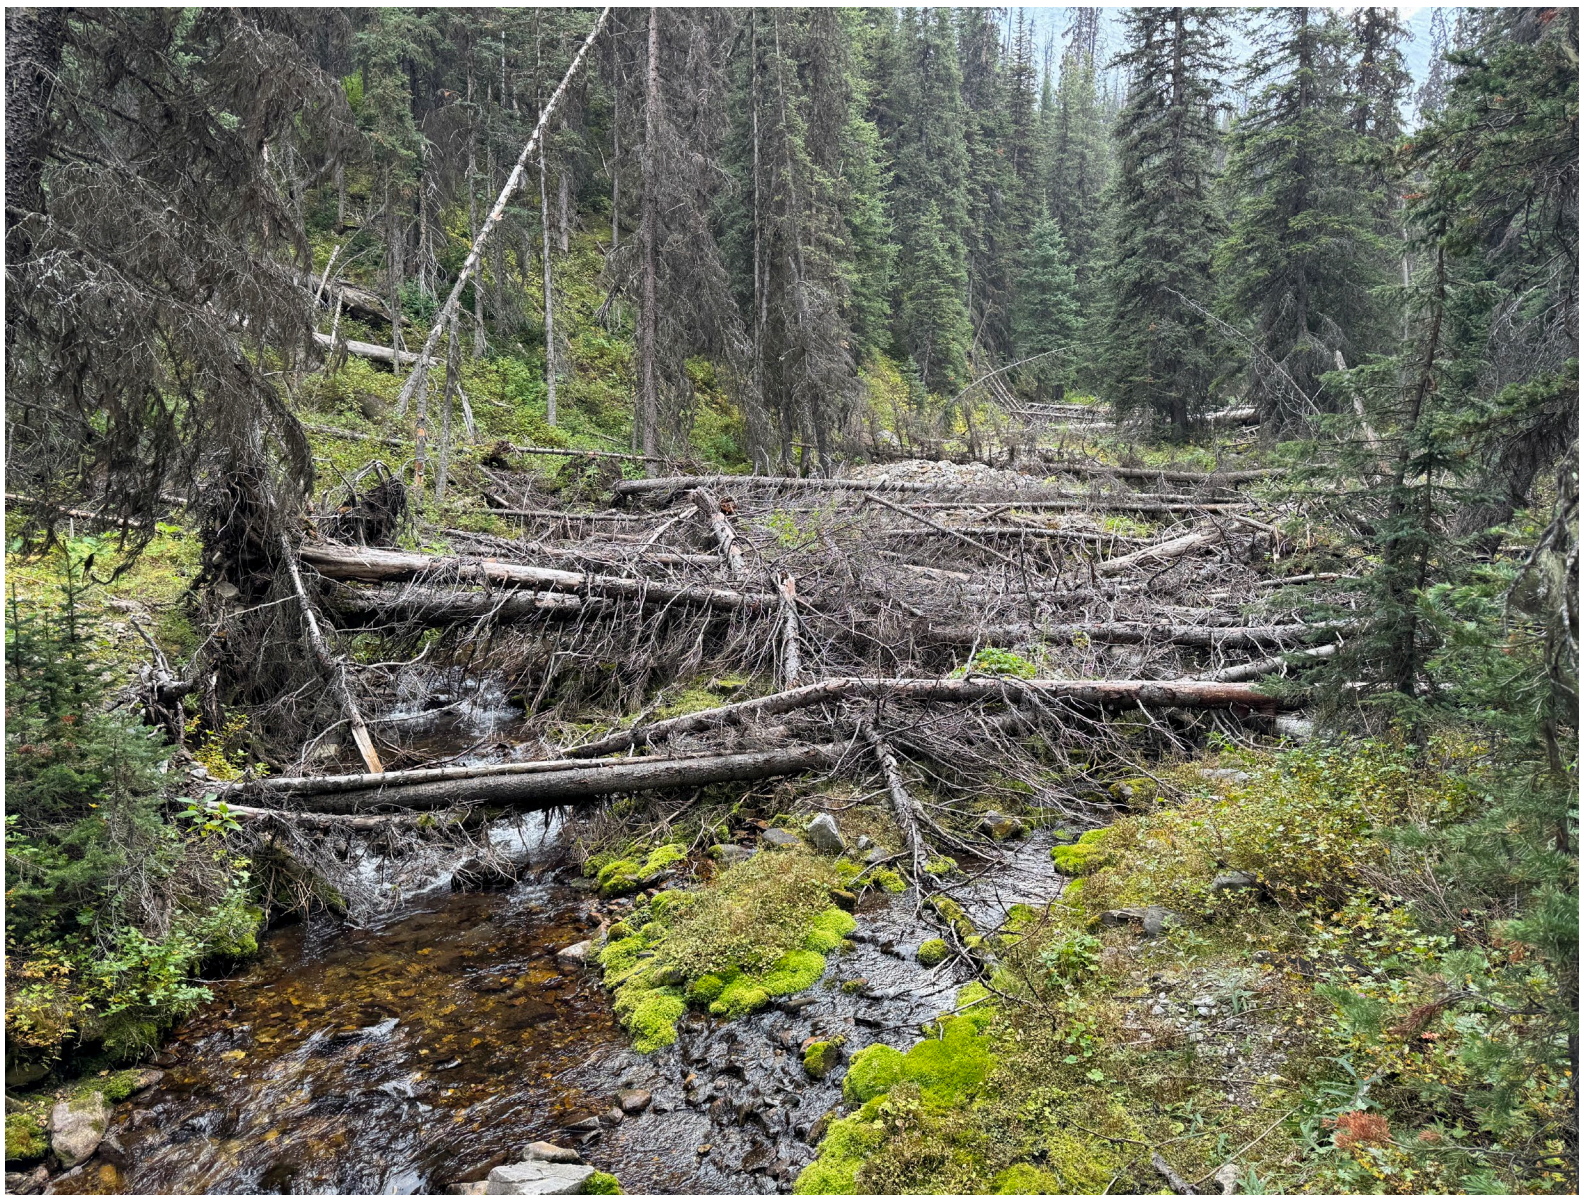
**Photo IV- 2. LWD log jam in Loomis Creek headwaters.**

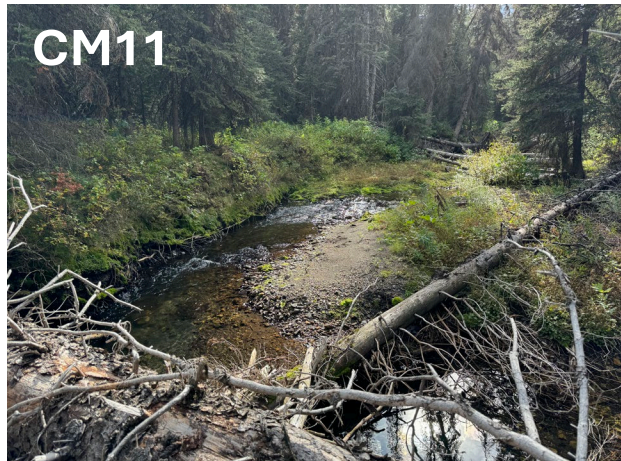
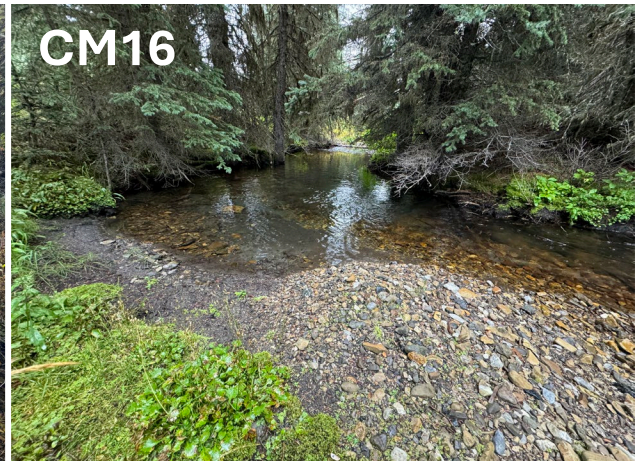
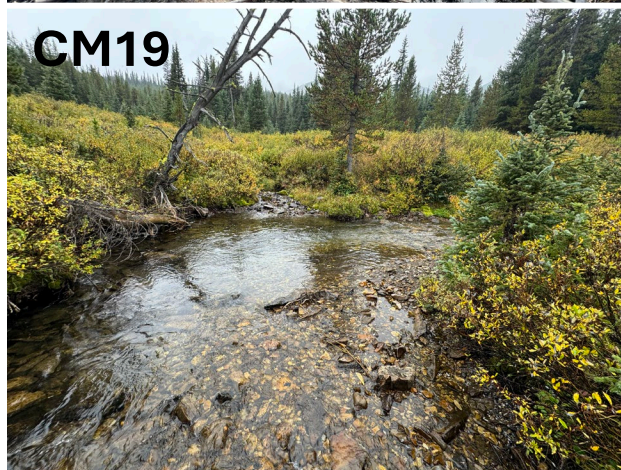
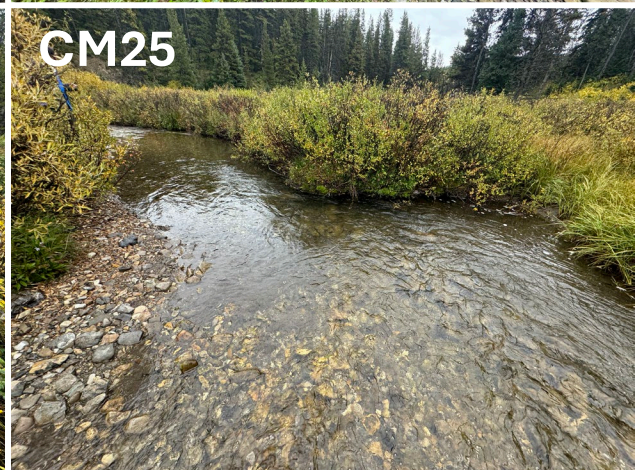
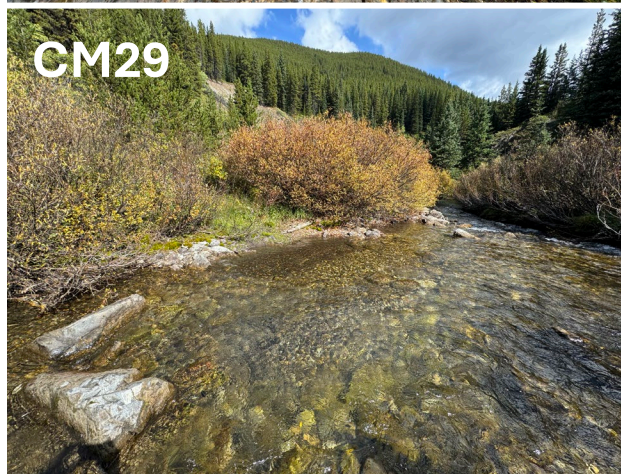
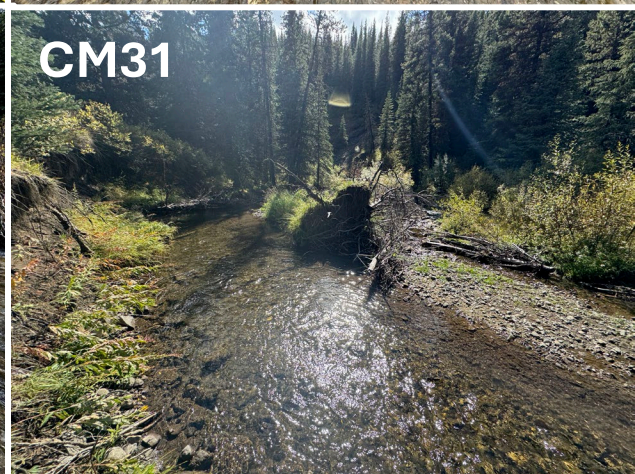
Downstream of the headwaters, riffle pool channel morphology predominates along the mainstem of Loomis Creek throughout the mid-reach and stream gradient is consistently 2-3% (**Photo IV- 3**). Riffle pool morphology was recorded at [Online Map Site ID CM11](#) below the confluence of the two largest tributaries on the North side of Loomis Creek (LSBN8, LSBN9), upstream of, within, and downstream of the beaver meadows ([Online Map Site IDs CM16, CM19, CM25](#)), and below the confluence of Bishop Creek ([Online Map Site ID CM29](#)) to the Low Gradient Crossing ([Online Map Site ID CM31](#)). In this reach, larger pools are present, but they are spaced further apart (one every 5-7 channel widths). LWD is abundant in the mid-reach of Loomis Creek upstream of the beaver meadows (**Photo IV- 4**), with riparian trees falling from collapsing banks and remaining in place, suspended over the channel, until decay results in them collapsing into the channel ([Online Map Site IDs CM11, CO046, CO085, CO097, CO098, CO100, CM16, CO104](#)). The low stream gradient and broader floodplain are not conducive to sweeping LWD downstream. LWD is largely absent within the beaver meadows due to trees being absent from the floodplain adjacent to the channel. Downstream of the beaver meadows and upstream of the Low Gradient Crossing, LWD abundance increases but remains low relative to the reach upstream of the beaver meadows due to a less dense riparian forest.

Photo IV- 3. Riffle-pool channel morphology at six sites on the low gradient mid reach of Loomis Creek with [Online Map](#) Site IDs.

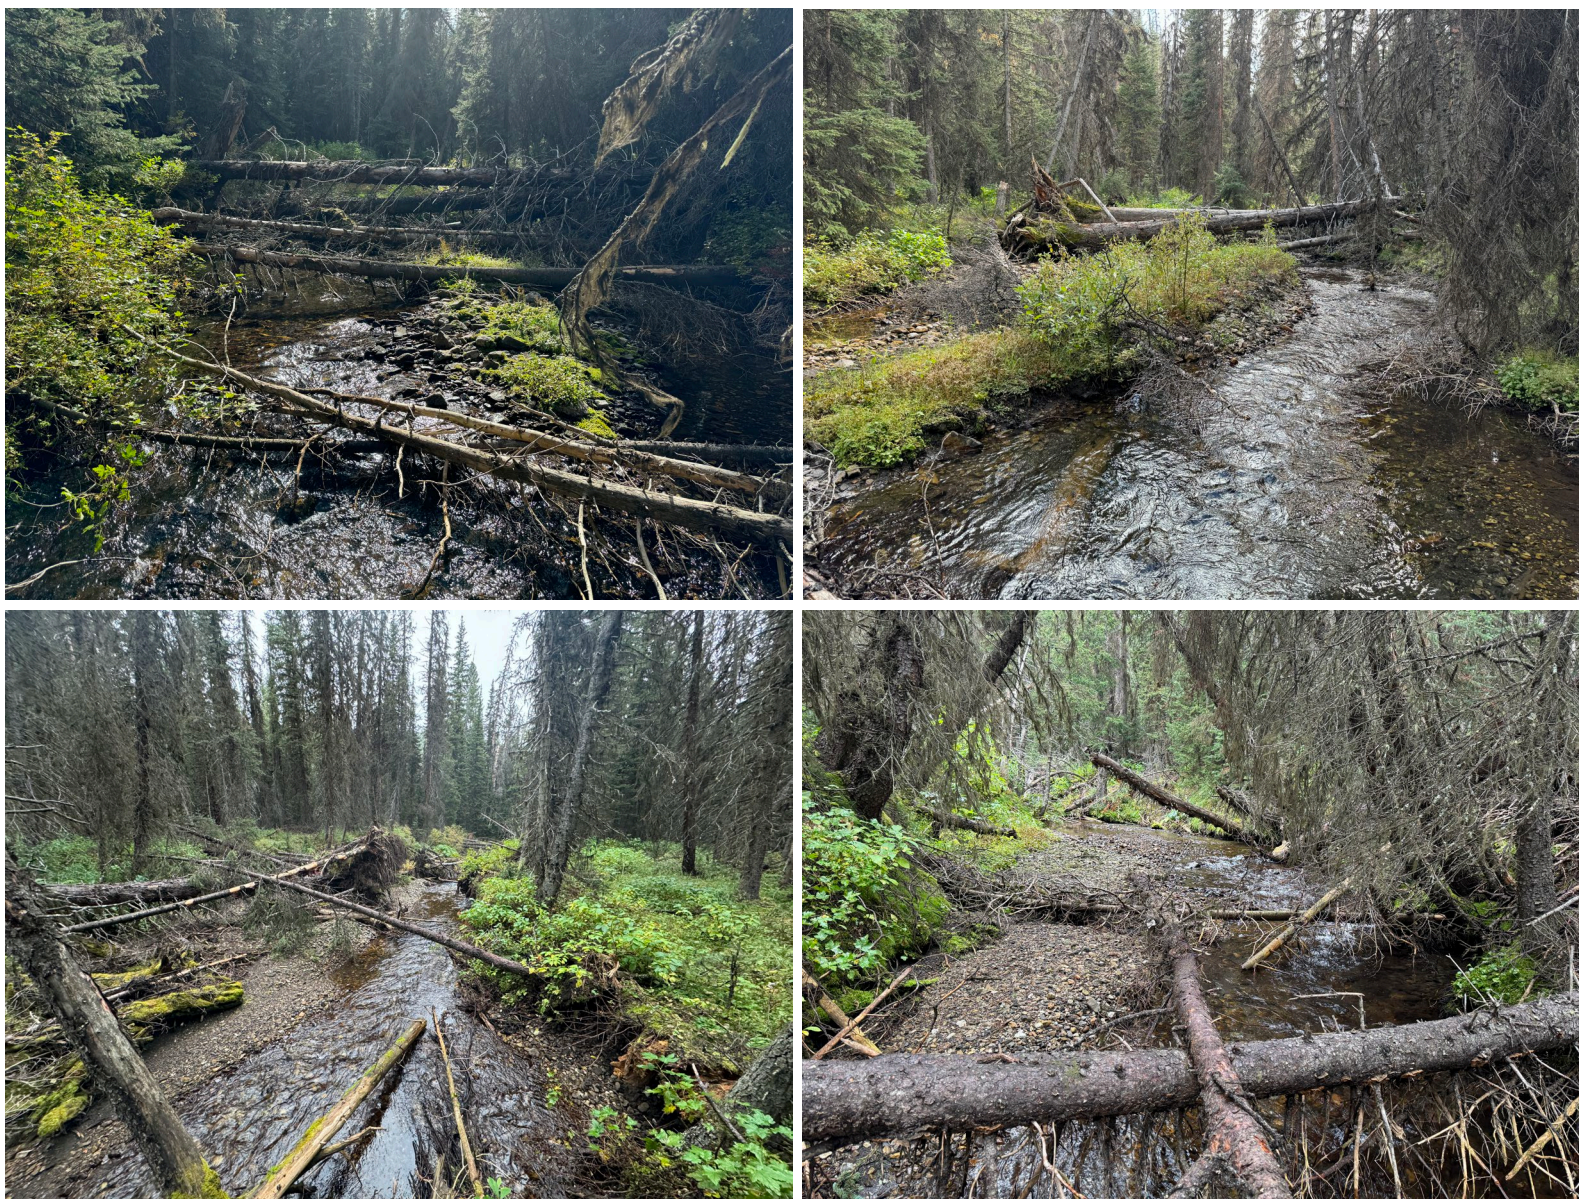
**Photo IV- 4. Abundant LWD in the mid reach of Loomis Creek upstream of the beaver meadows.**
