# Loomis Creek Eco-hydrology Phase 1 Study: 2024-2025

May 27, 2025

Fintegrate file #: 2025-CPAWS-01

**Prepared for:**

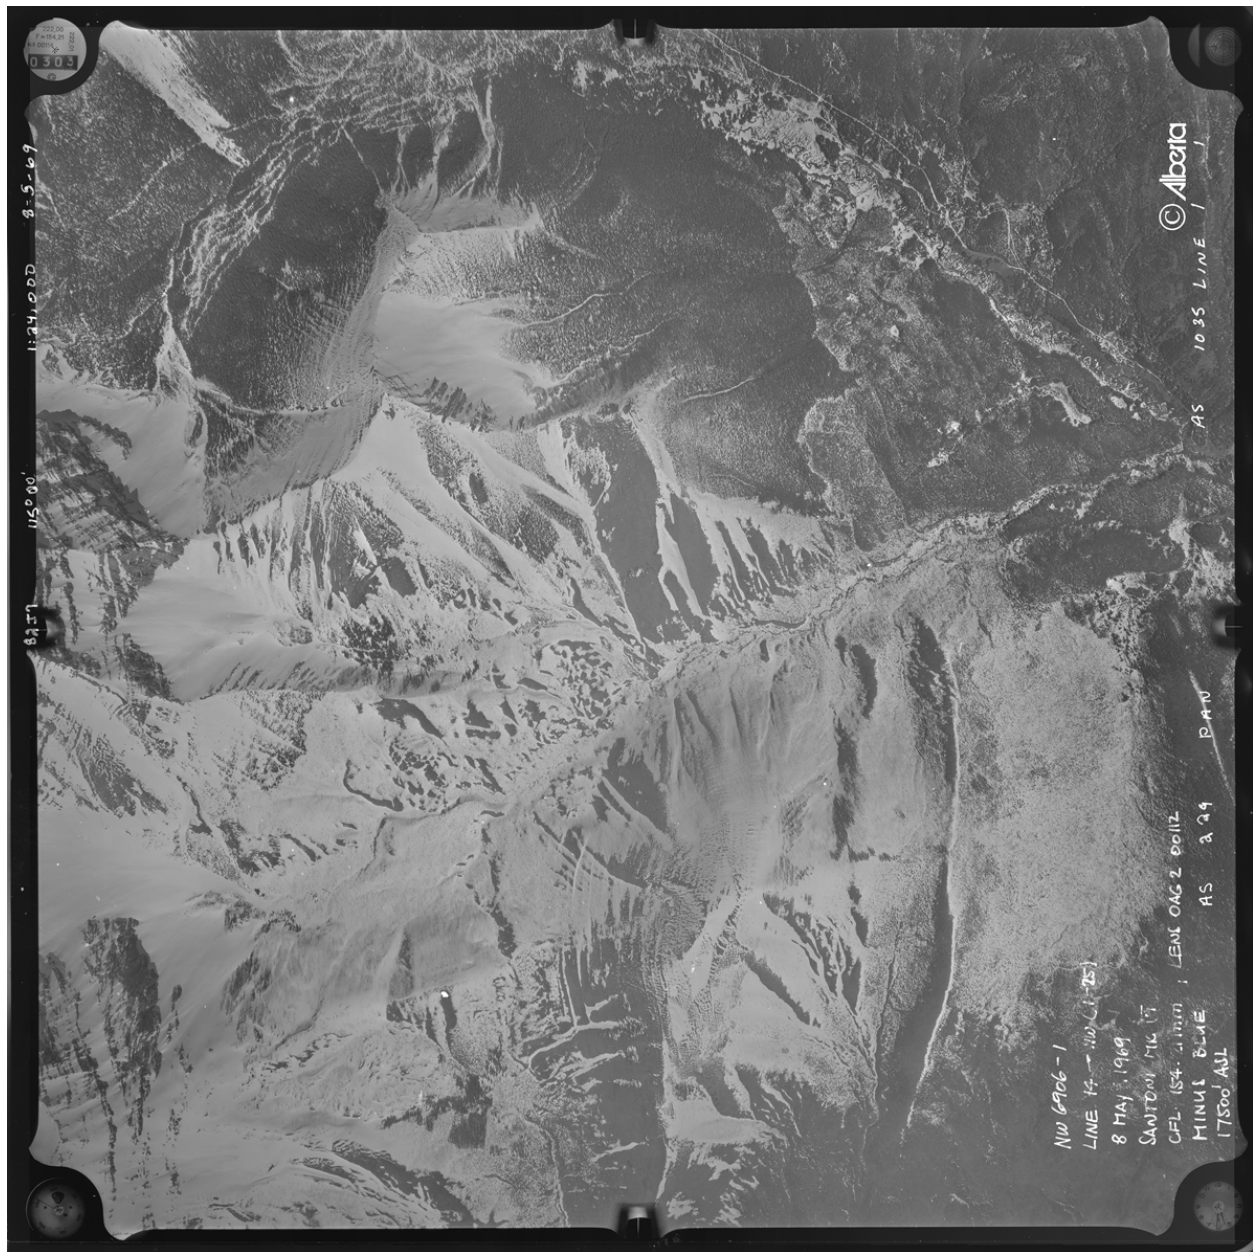
**Photo IV- 11. Air photo (1969) showing Bishop Creek, LSBS6, and Loomis Creek headwaters.**

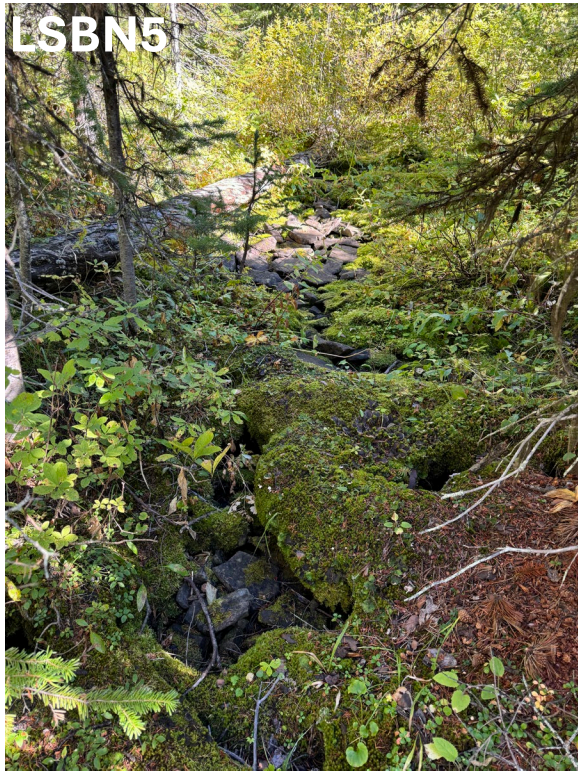
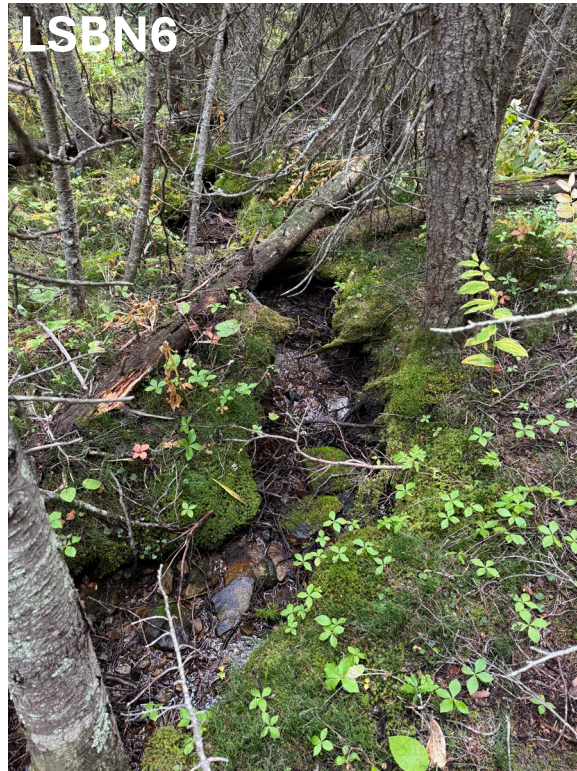
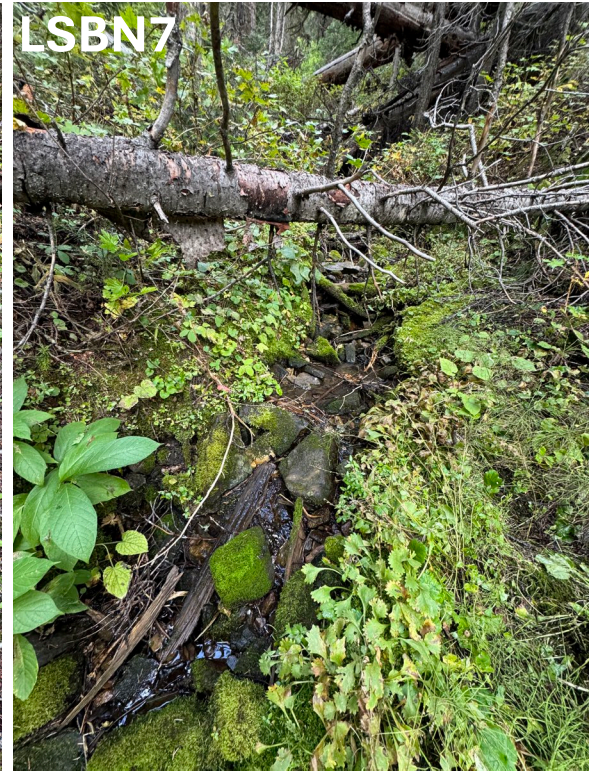
A colluvial channel morphology form was assessed on LSBN7, LSBN6, and LSBN5 at the sites upstream of the historical logging (**Figure 13, Photo IV- 12**; see [Online Map Site IDs CM13, CM15, CM18](#), respectively). At these upper sites on LSBN7 and LSBN6, steep

**Photo IV- 12. LSBN5, LSBN6, LSBN7 channels upstream of or within unbuffered clearcuts.**

gradients (**Table IV- 2**; 29% and 22% at [Online Map](#) Site IDs CM13 and CM15, respectively), in combination with limited flows at these sites, resulted in only small gravel and silt being mobile (**Table IV- 3**; D90 ranges from 0.1-1.0 cm). At the upper site on LSBN5 ([Online Map](#) Site ID CM18) the gradient is lower (**Table IV- 2**; 5%), and only silt is mobile (**Table IV- 3**; D90 = 0.1 cm).
